UTTARKASHI EARTHQUAKE

OCTOBER, 20, 1991

GEOLOGICAL SURVEY OF INDIA

SPECIAL PUBLICATION NO. 30

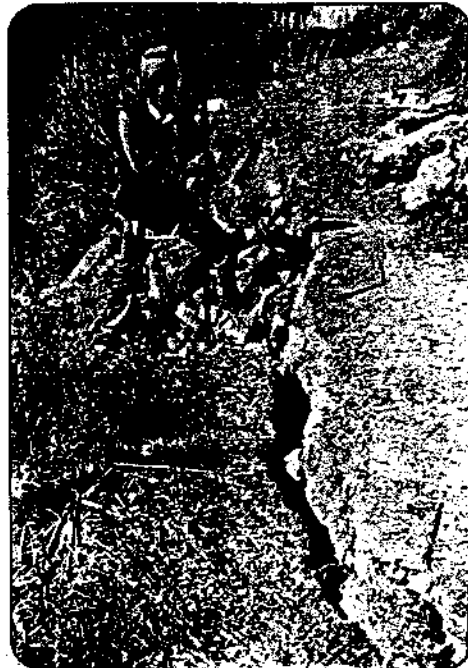
Photo 12 *NE-SW trending fissure on the debris covered slope on the Saura Byala Tipri mule track.*

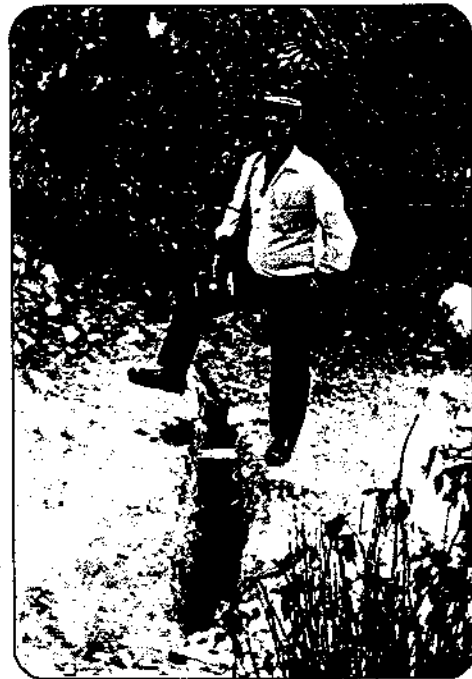
Photo 12 A *50 cm. open crack trending NNW-SSE along Manerijamak foot track.*

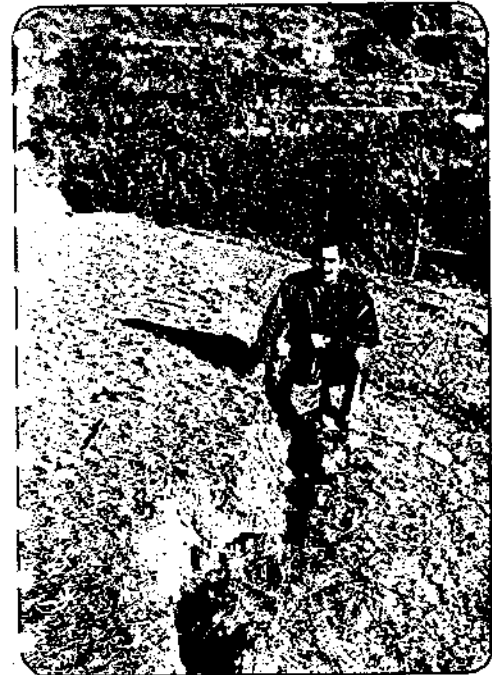
Photo 12 B Nearly 5 cm long open slump fissure in the cultivated fields of Kamar village.

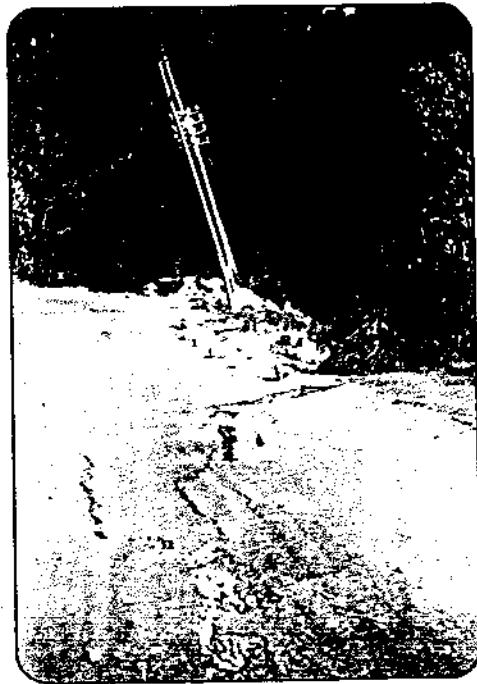
Photo 13 Arcuate ground fissures cutting the black top surface of road near Maneri.

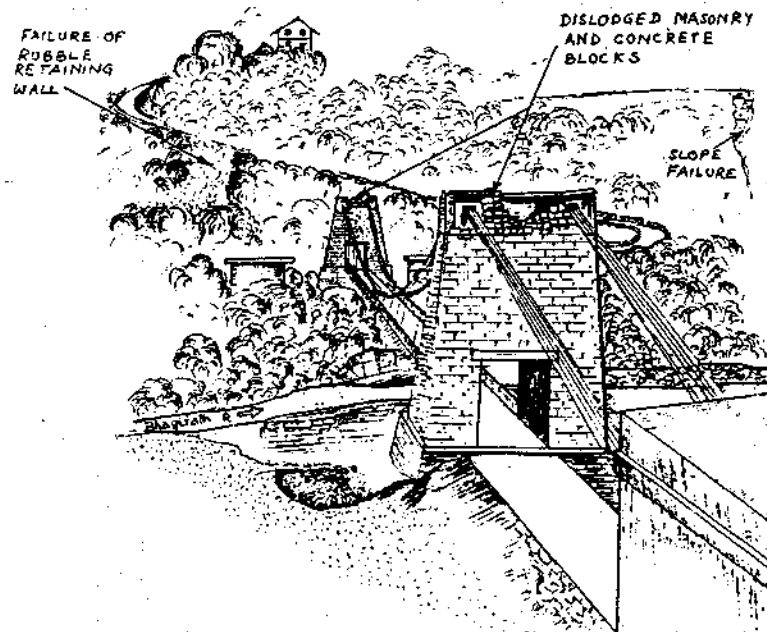
Fig. 5 SKETCH OF LATA SUSPENSION BRIDGE SHOWING DAMAGES TO THE ABUTMENT TOWERS (SKETCH BY P. PANDE)

The single span, 100m long foot suspension bridge at Lata, aligned in NW-SE direction has suffered similar damages as that at Siror but the intensity of ground motions here appears to be more. The masonry tower at the left bank has collapsed in the top portion and the concrete slabs enclosing the cables are slightly dislodged (Fig.5). All the cables are intact and the bridge is fully serviceable.

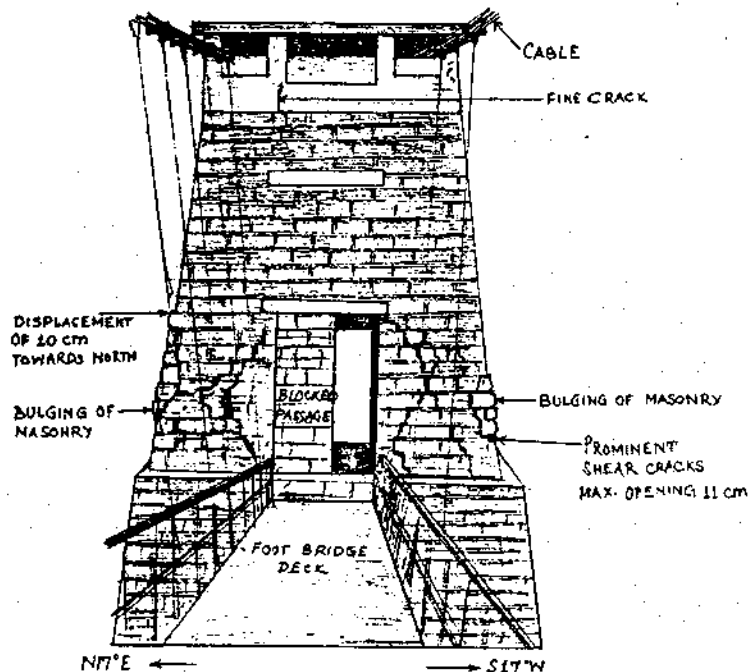
The 76.20m long Dedsari suspension bridge, constructed in the year 1979 has been analysed in detail. The foot bridge has survived the earthquake but has been damaged to some extent. The left abutment suspension tower constructed of masonry has developed prominent shear cracks on the $N17^{\circ}W-S17^{\circ}E$ trending faces (Fig.6). The cracks which extend to a height of 3m from the ground have maximum opening of 11cm. A fine, vertical crack extending for about 1m is also seen at the top portion of the tower. The upstream, WNW-ESE trending face of the tower shows a displacement of the order of 10 cm and bulging.

Fig. 6 : SHEAR CRACKS IN THE LEFT ABUTMENT TOWER, DEDSARI SUSPENSION BRIDGE (SKETCH BY P. PANDE)

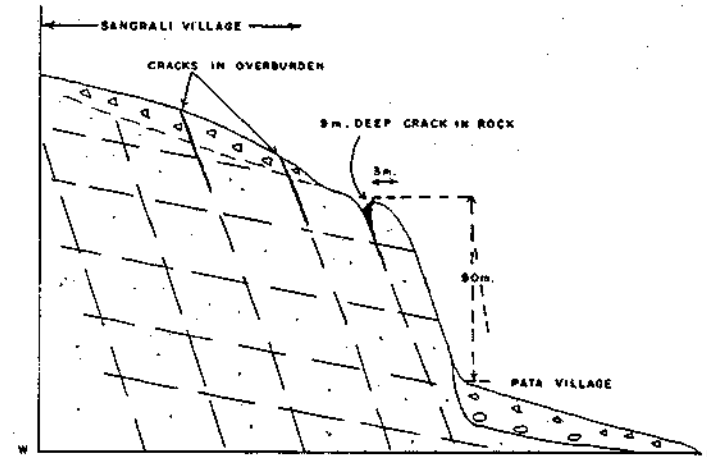
Fig. 7: CRACKS IN SANGRALI VILLAGE.

and has been measured to a depth of 9m (Photo 10). At an isolated location the width of this opening is about 50cm. This crack is oriented in the N-S direction i.e. parallel to the cliff face. Because of the earthquake the unsupported side i.e. the cliff face has lead to the opening of rock blocks along pre-existing joint surfaces which are probably the controlling features for development of the cliff face. A sketch demonstrating the mechanism of formation of this crack is enclosed as Fig.7.

The strong ground motions have dislodged or displaced some of the rock blocks or wedges, particularly those located near the scarp face, thereby giving rise to the appearance of ground cracks (Fig.7).

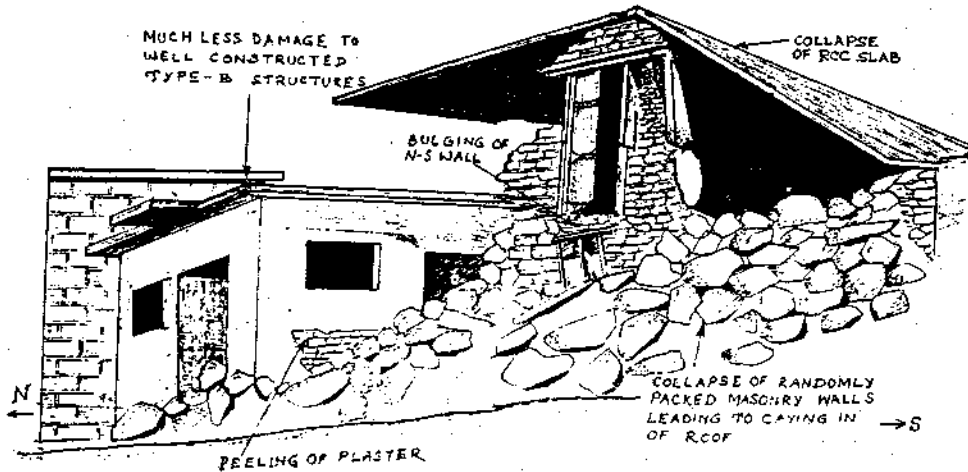
Fig.8 : SKETCH SHOWING EXTENT OF DAMAGES TO TYPE 'A' AND TYPE 'B' CONSTRUCTIONS IN SAURA VILLAGE (SKETCH BY P. PANDE)

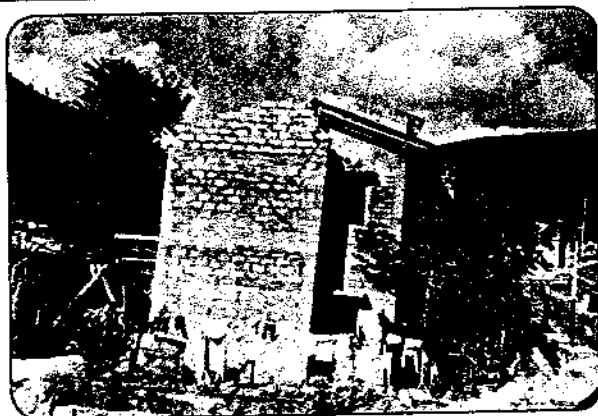
Photo 23 Shear cracks and partial collapse of the first floor of a house in Tileth colony, Uttarkashi.

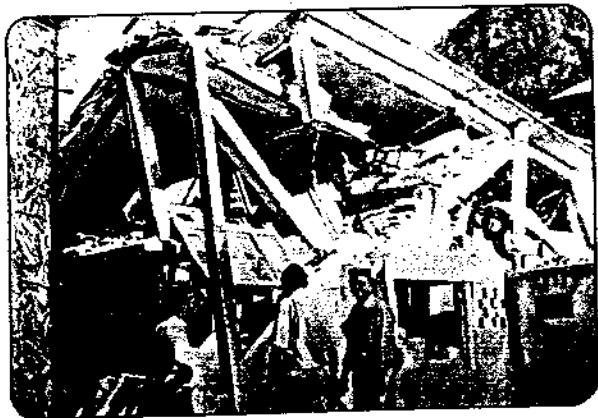
Photo 24 Collapse of the first floor of RCC, State Bank of India building in Uttarkashi.

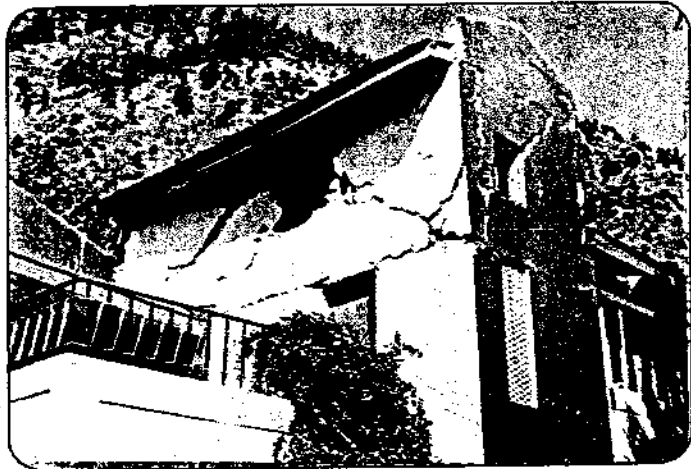
Photo 27 Heavily damaged first floor of the Maneri inspection house with shear cracks in both long and short walls.

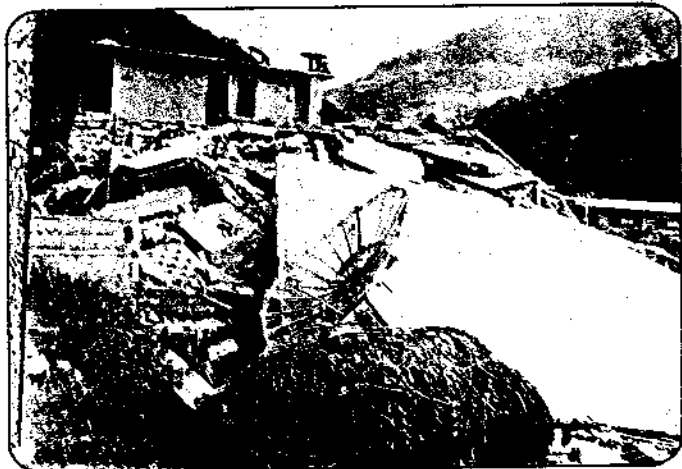
Photo 30 Complete collapse of a house with RCC roof at Aungi village. Note relatively much less damage in a house at the top left corner.

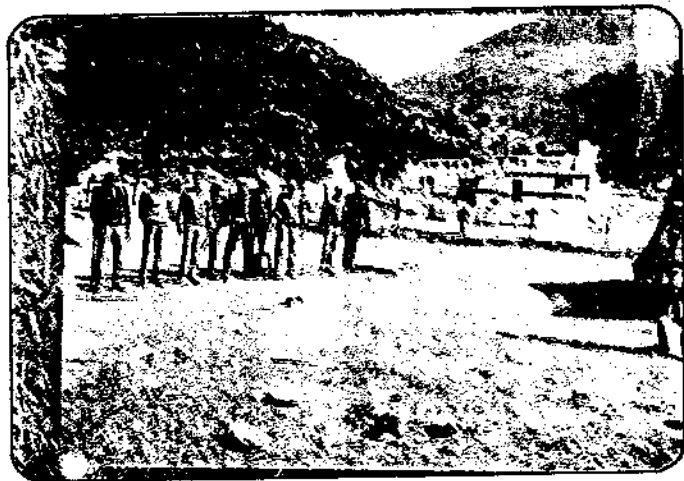
Photo 31 Damaged NW-SE aligned block of Gov. Inter College at Aungi. Note complete collapse of the block oriented in the NE-SW direction behind the policemen.

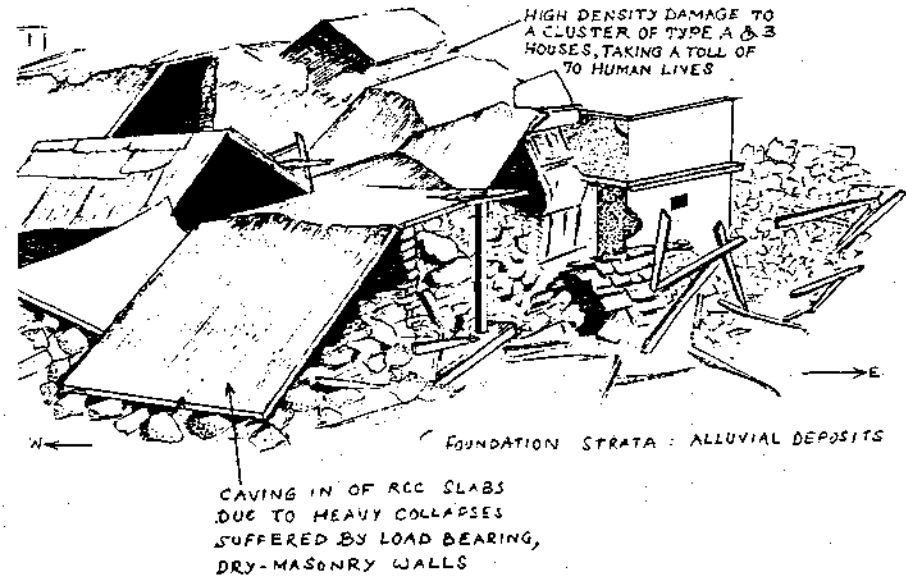
The village is located on a high level alluvial deposit of an abandoned channel, on the left bank of river Bhagirathi, at a distance of 0.5 km south east of Maneri dam. Jamak bore the maximum brunt of the 20th October earthquake, where 70 persons got killed and almost all the remaining were injured. The intensity of ground motions was so high that nearly 90% of the dwellings were either razed to the ground or suffered heavy damage, making them unfit and unsafe for habitation. The village thus bears a deserted look with all the inmates having moved to the neighbouring fields in make shift hutments (Photo 45).

Fig. 9: DAMAGE IN JAMAK VILLAGE (SKETCH BY P. PANDE)

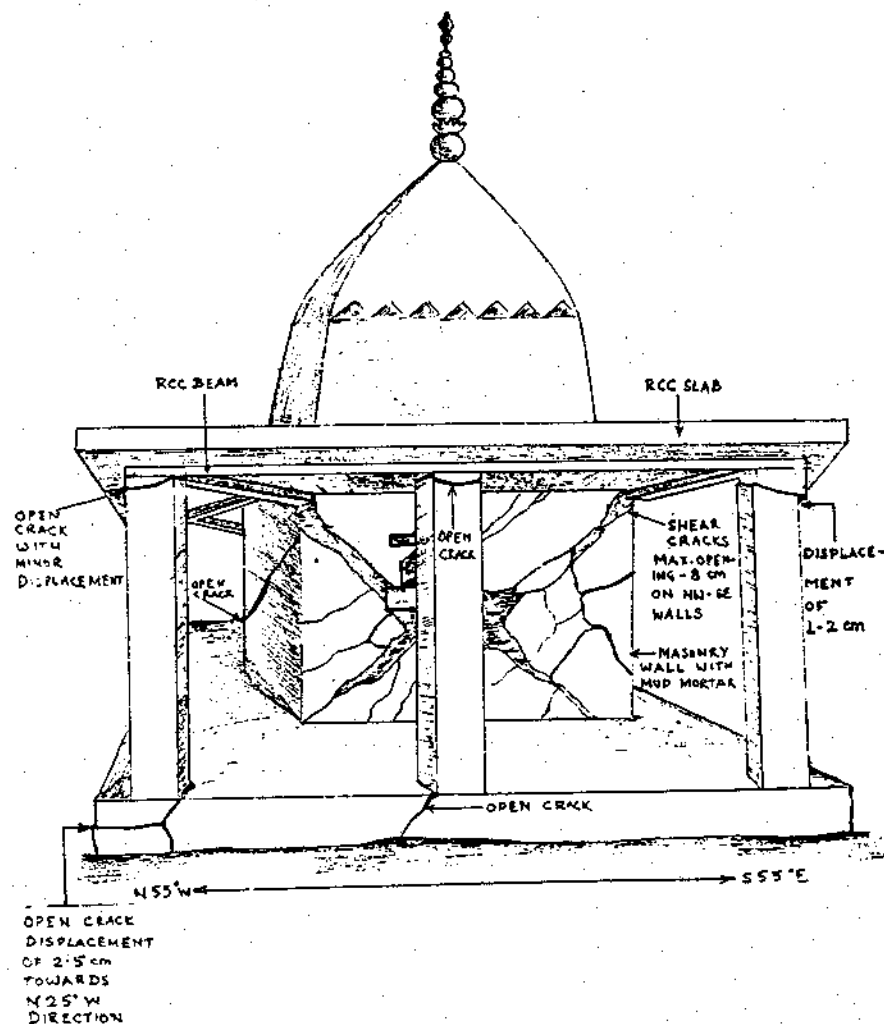
The N55°W-S55°E trending faces of the sanctum walls have developed prominent cross shaped shear cracks. The columns have invariably sheared near the beam contact. A displacement of the order of 2cm towards N15°E direction has been measured in one of the corner pillars. Open cracks have also appeared in the floor, particularly around pillar contacts.

Fig. 11. DAMAGE TO KALINAG TEMPLE, DEDSARI VILLAGE (SKETCH BY P. PANDE)

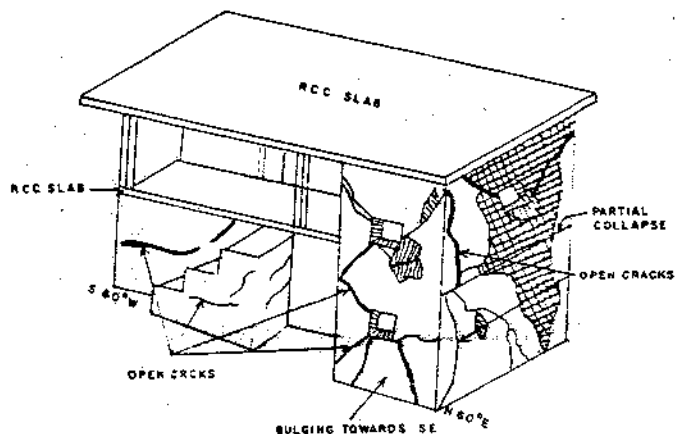
FIG. 17: HOUSE OF SAHDEV SINGH AND GYAN CHAND, PALA

The house of Sahdev Singh and Gyan Chand has its long wall aligned in $N60^{\circ}E-S60^{\circ}W$ direction (Fig.17 and Photo 62). It is a stone masonry house with RCC slab roof. The house is double storeyed with the stair case located outside. The southeastern wall has suffered damage in the form of open cracks (upto 5 cm) which are more pronounced near the windows and extend towards the edges. Bulge towards SE was also noticed below the window in this wall. Similarly, the projections on this wall like stair case have also suffered cracks. The NE wall (aligned $NW-SE$) has suffered more damage in the form of partial collapse and development of open cracks. The collapse is more pronounced at upper portion of building as compared to lower. Similar damage, but of lesser intensity has been noticed in a number of houses.

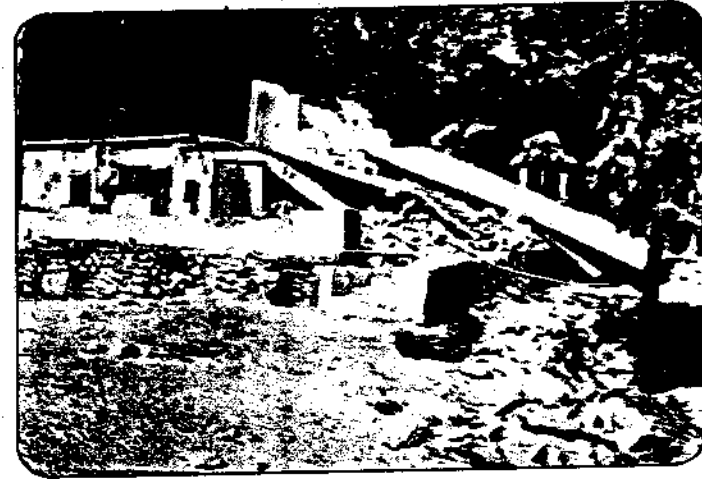
Photo 59 Collapse of wall and slided RCC slab, Bhatwari village.

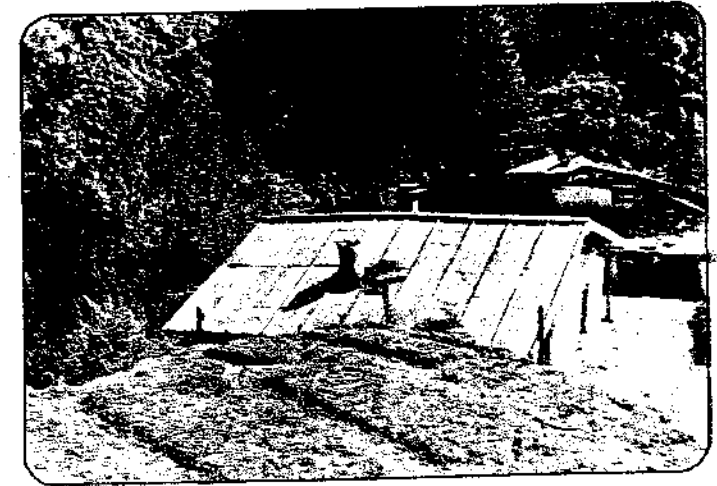
Photo 60 Damaged PWD Rest house building, Bhatwari. Chimney slab of the out house thrown on G. I. sheet roofing.

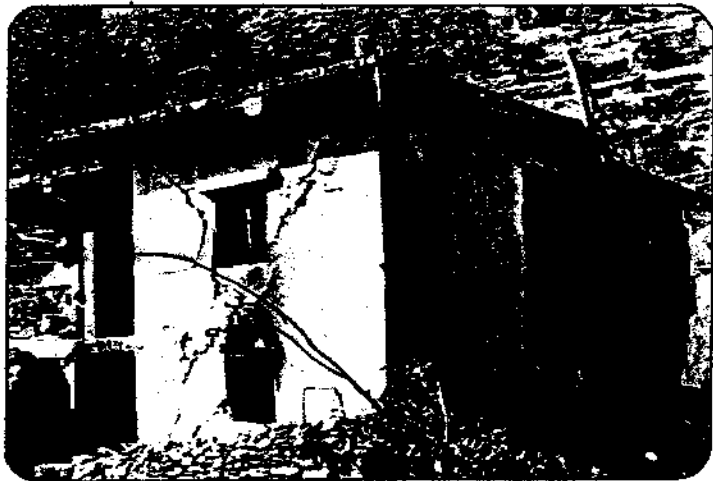
Photo 62 *Open shear cracks in NE-SW wall and partial collapse of NW-SE wall in the house of Sahdev Singh of village Pala.*

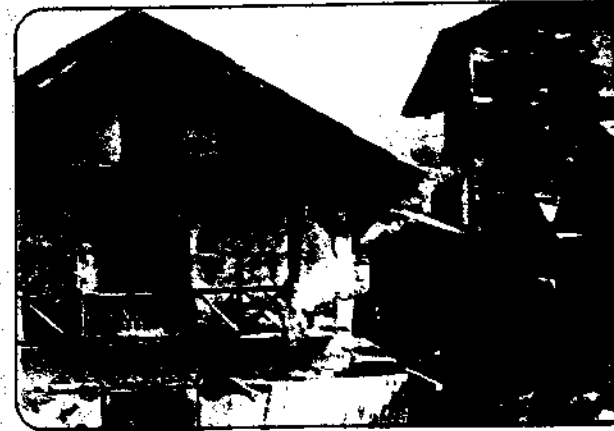
Photo 64 *View of an old conventional house with wooden beams and columns displaying gaping shear cracks in Sirov village.*

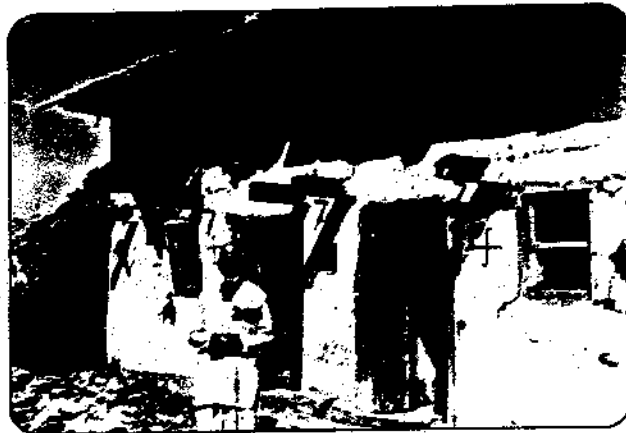
Photo 69 Partial collapse of the corner of the first floor of a house in Thalan village.

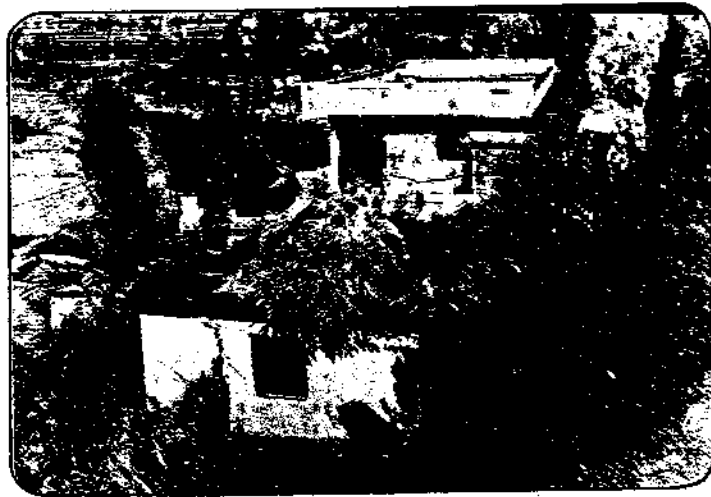
Photo 80 Shear cracks in a house in Thati Kuthur village.

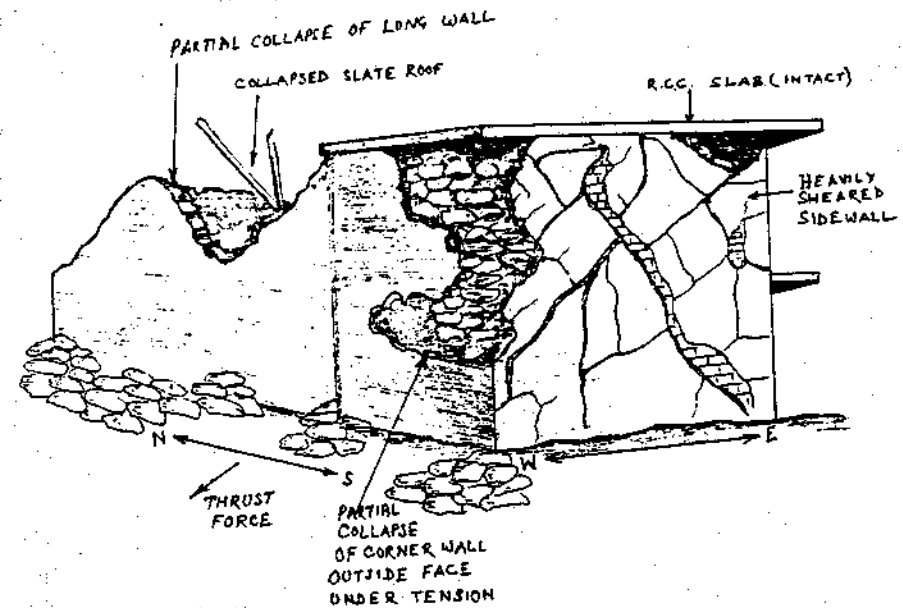
Two buildings of the village have been analysed in detail. The first building has its side walls aligned in E-W direction and the long walls in N-S direction (Fig.29). The southern part of the house has RCC slab as roofing where as the northern portion has the conventional slate roofing. The side wall has developed very prominent shear cracks some of which have wide openings (Photo 83). The masonry at the slab junction has collapsed at places. The long wall has suffered partial collapse towards the western side. The south western corner of the building shows partial collapse of the outside face of the masonry wall under tensional force.

Fig. 29: PATTERNS OF DAMAGE TO A HOUSE IN GORTHI VILLAGE TEHRI DISTRICT, (SKETCH BY P. PANDE).

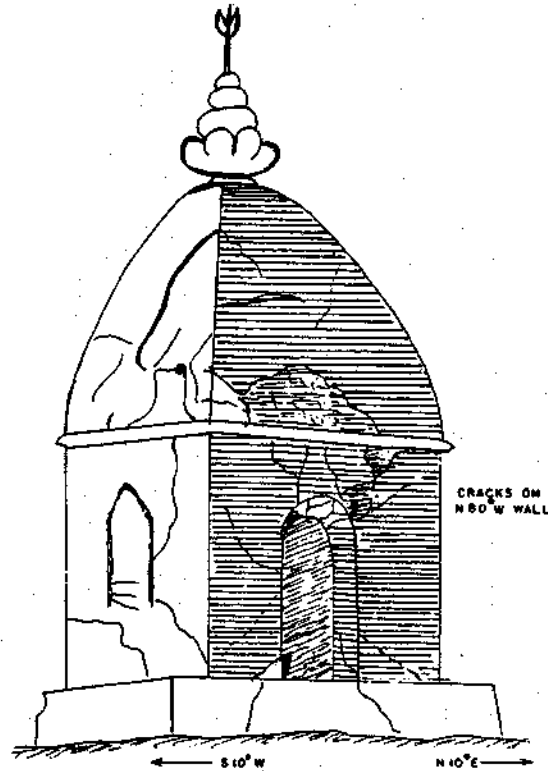
FIG.31: SHIV TEMPLE, JAKHOLI. SHEAR CRACKS ON WALL ALIGNED $N10^{\circ}E - S10^{\circ}W$.
KALASHA SHIFTED TOWARDS $N30^{\circ}E$ BY 2CM.

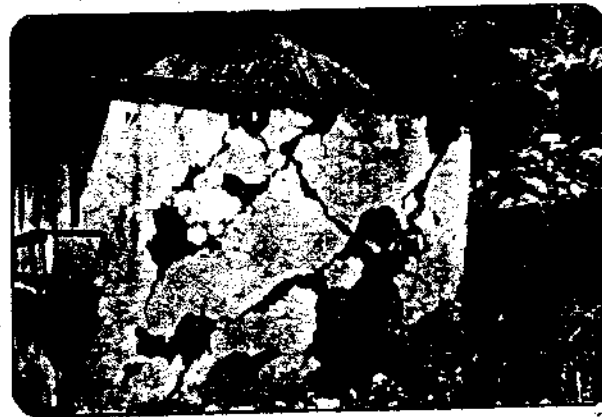
Photo 83 Heavily sheared side walls of a house in Gorthi village.

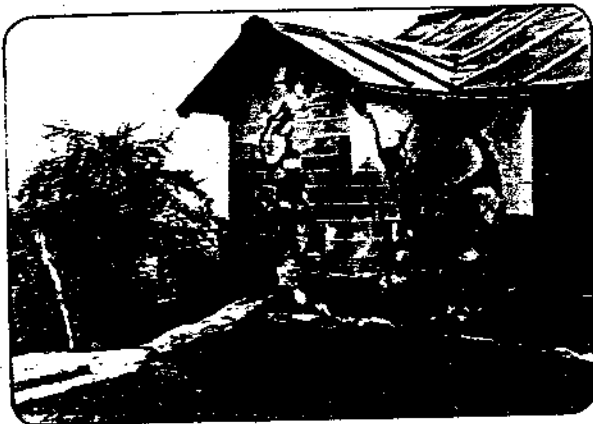
Photo 84 *Damaged residence of doctor in Jakheli village.*

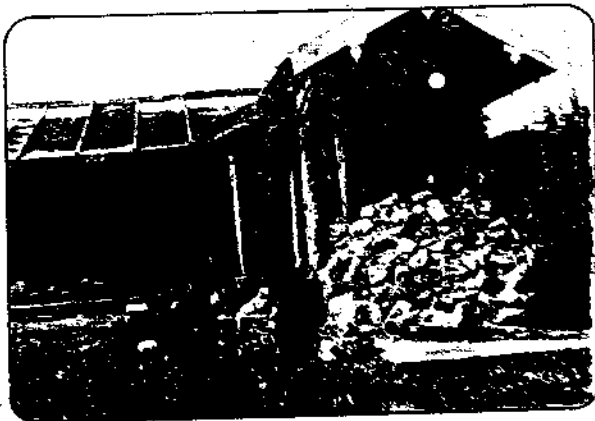
Photo 85 *Collapse of a type-B house in Jakholi village located on a spur.*

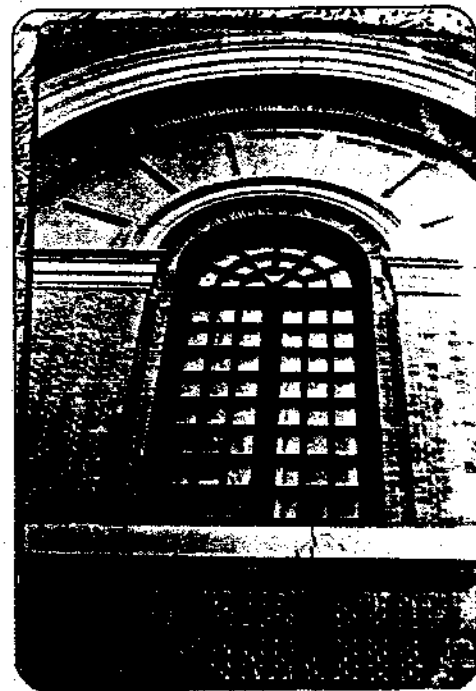
Photo 96 *Cracks in the arch and sill portion, in the rear wall of FRI building.*

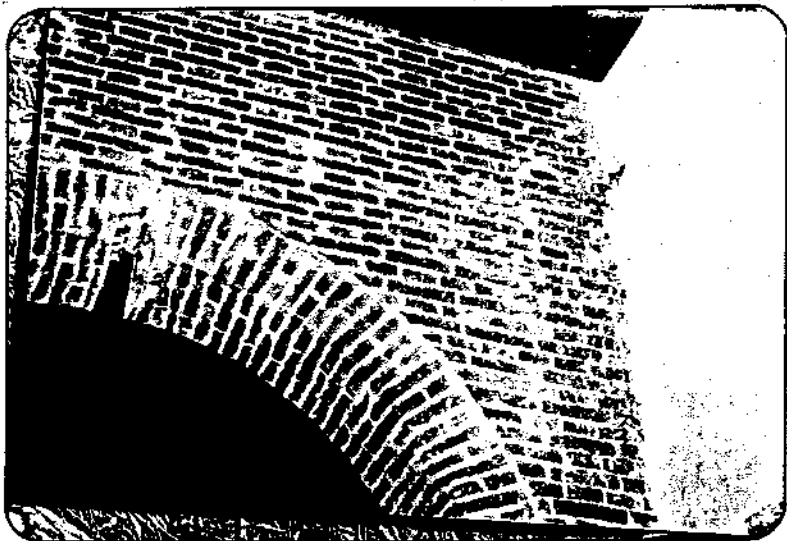
Photo 97 Dislodged brick from the centre of the arch portion of the first floor corridor-FRI building Dehradun.

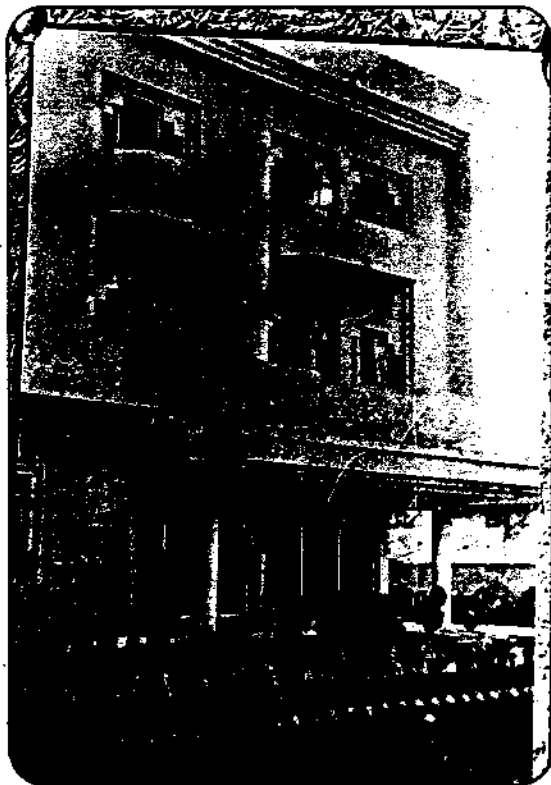
Photo 98 Fall of plaster and development of cracks in the panel wall adjacent to the porch-Hilton Hotel, Dehradun.

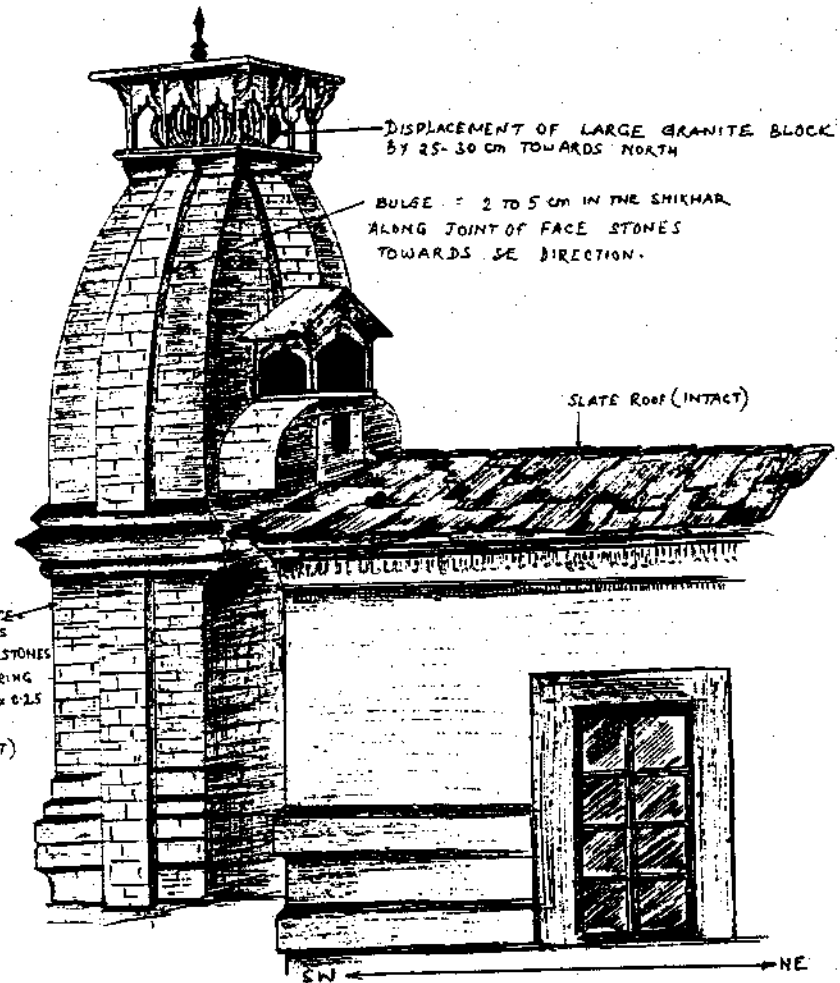
Fig 32: SKETCH SHOWING BULGE IN THE SHIKHAR AND DISPLACEMENT OF AMBLAKH OF TRIYUGI NARAYAN TEMPLE, CHAMOLI DISTRICT (SKETCH BY P. PANDE)

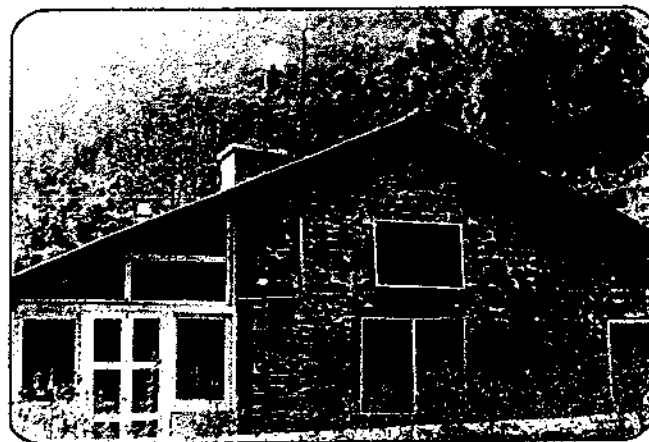
Photo 112 *Bulging and cracking around the ventilator and partial collapse of the gable portion of the PWD Rest house, Gaurikund.*

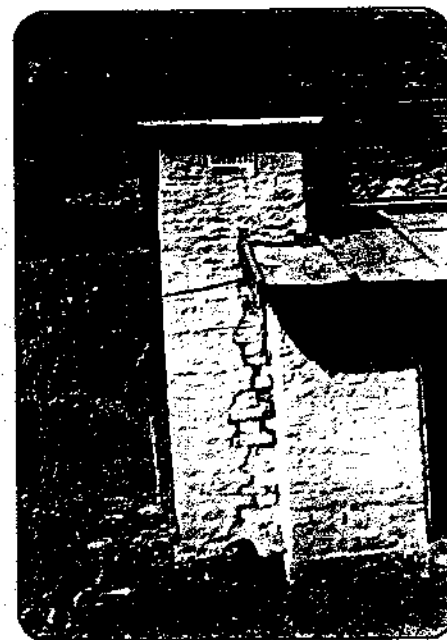
Photo 113 *Separation and cracking of chimney in the out house of PWD Rest House, Gaurikund.*

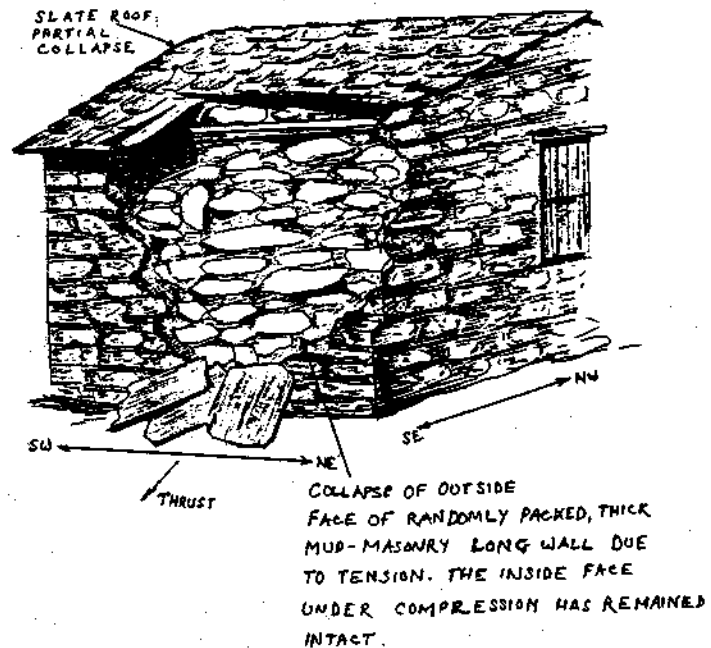
Fig. 37: PARTIAL COLLAPSE OF MUD MASONRY WALL UNDER TENSION, GAURI GRAM, DUGADDA (SKETCH BY P. PANDE)
