A REPORT ON

CHAMOLI EARTHQUAKE OF MARCH 29, 1999

DEPARTMENT OF EARTHQUAKE ENGINEERING
UNIVERSITY OF ROORKEE
ROORKEE - 247 667
INDIA

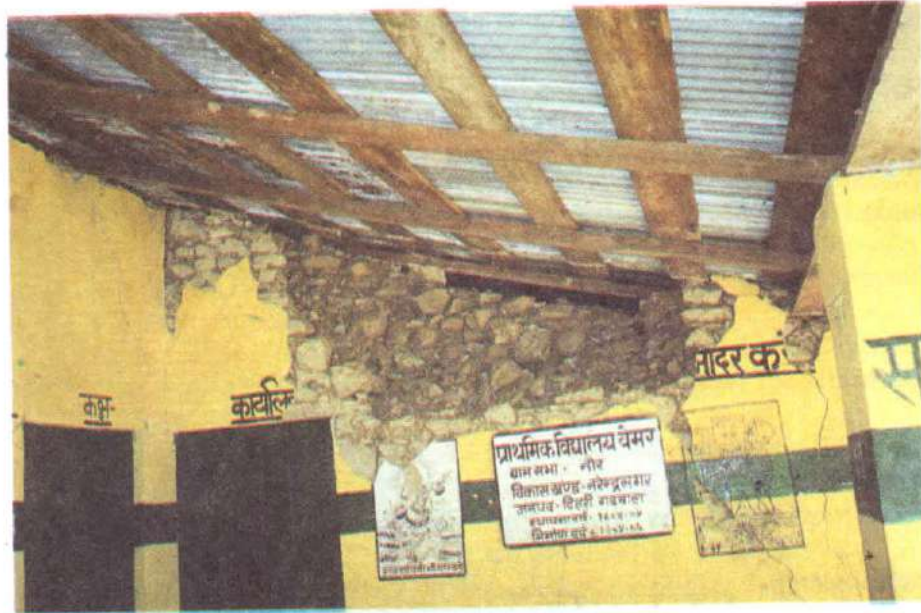
Fig. 2 Damaged primary school at Bemar

The primary school at Bemar built in random rubble masonry in 1985 at a distance of about 20 km from Narendranagar suffered Grade 3 damage. Figure 2 shows the delamination of the walls of the school because of lack of bond stones. The boundary wall about 75 cm thick got separated from the middle as shown in Fig. 3. However, the Jalagam Prabandh Yojna building (Type B) located at about 50 meters away from the Bemar primary school suffered no damage. Type A structures in the village Jalal located at about 3km NW of Bemar suffered Grade 1 damage. Intensity VI- is assigned to this locality.

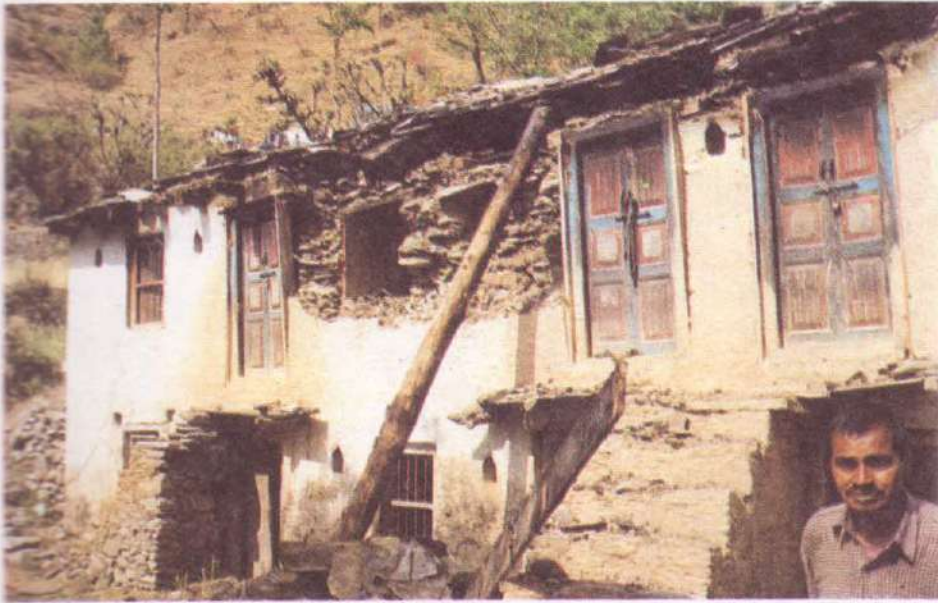
Fig. 8 Damaged house at Mehar

The village Mehar situated on the road leading to Bhatwari and Chaura experienced almost total damage. Figure 8 shows the damaged houses of village Mehar. Two parallel cracks of about 10 to 12 meters apart and approximately half cm wide were developed in the ground for as long as 500 meters in this village (Fig. 9). These fissures were also reported on the top of the same hill at two places, which seems to be a slope failure case (local phenomenon). In the villages Bhatwari and Chaura almost all the stone masonry buildings were totally damaged (Category A damage of Grade 4 to 5) (Figs. 10 and 11). There was no Category B or C houses in these villages. All the people were very frightened. Two deaths were reported from the village Chaura. Mostly the damage was done to the walls in N20° to NS direction. Intensity VII- has been assigned to these places.

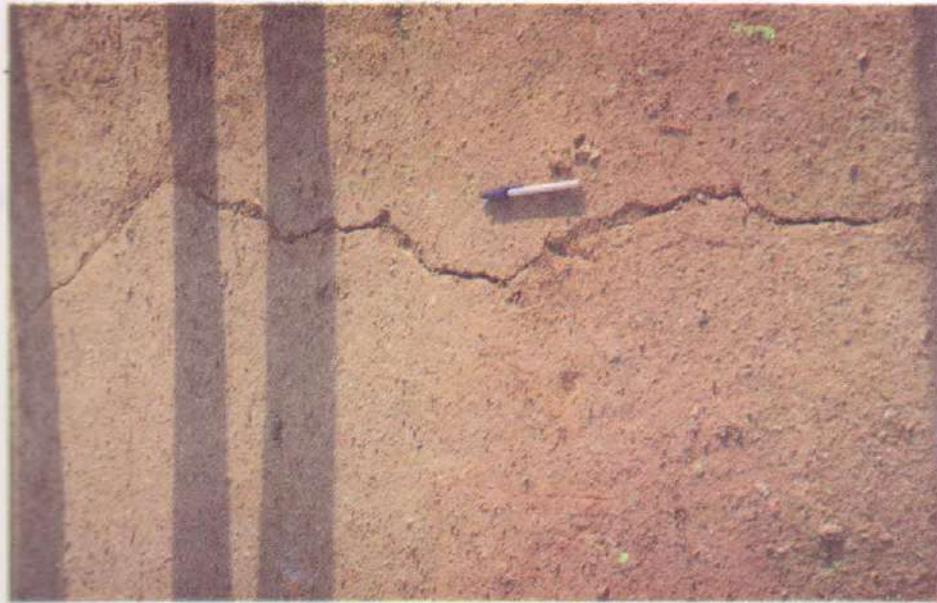
Fig. 12 Ground fissures at Chirbatia

Most of the kutchha houses were damaged in Chirbatia, which is the highest point in this area (2287m). Ground fissures of about half cm wide were seen prominently in N20° to NS direction in the ground for about 30 meters (Fig. 12). Similar types of fissures were also reported from the nearby places on the same slope. Wide cracks were observed in most of the houses as shown in Fig. 13. Most of the houses of Category A experienced Grade 2 to 3 damage. Intensity VI+ is assigned to this place.

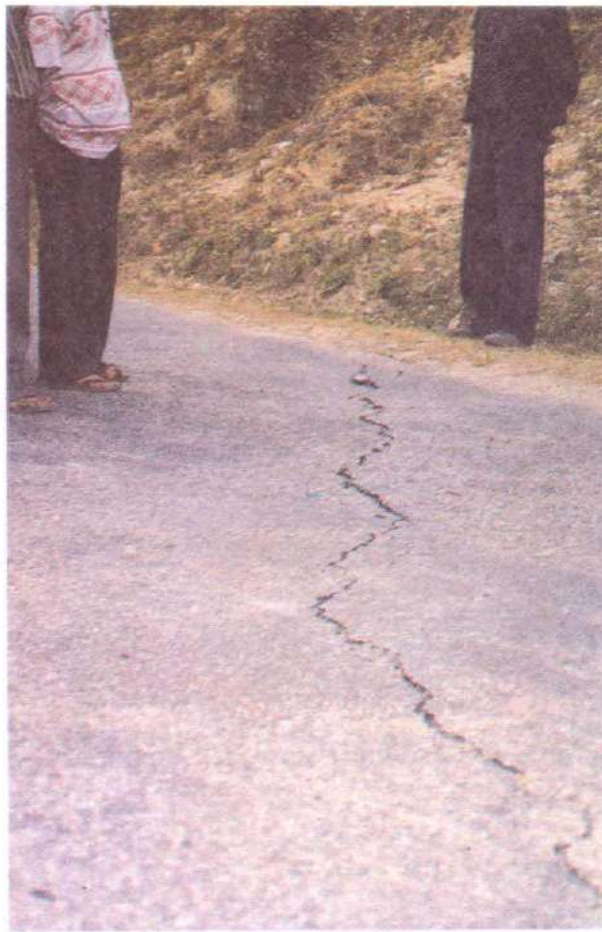
Fig. 14 Ground fissures at Indranagar

While moving from Chirbatia to Tilwara, four fissures of about 1 to 2 cm wide, 3 to 4m apart, running parallel to each other on the main road were seen at Indranagar, which is about 20km from Chirbatia (Fig. 14). One of the houses situated on the roadside was totally damaged due to fissures passing through it (Fig. 15). The fissures were also reported in the nearby villages. The same fissures were again seen after a distance of about 1km on the roadside. The fissures were on the same side of hillock and seem to be a slope failure case. The kutchha houses in the nearby villages were reported to be damaged in and around Rudraprayag town. As such no damage was observed in Rudraprayag township, which may be due to comparatively better construction in the area. Intensity VI+ is assigned to this place.

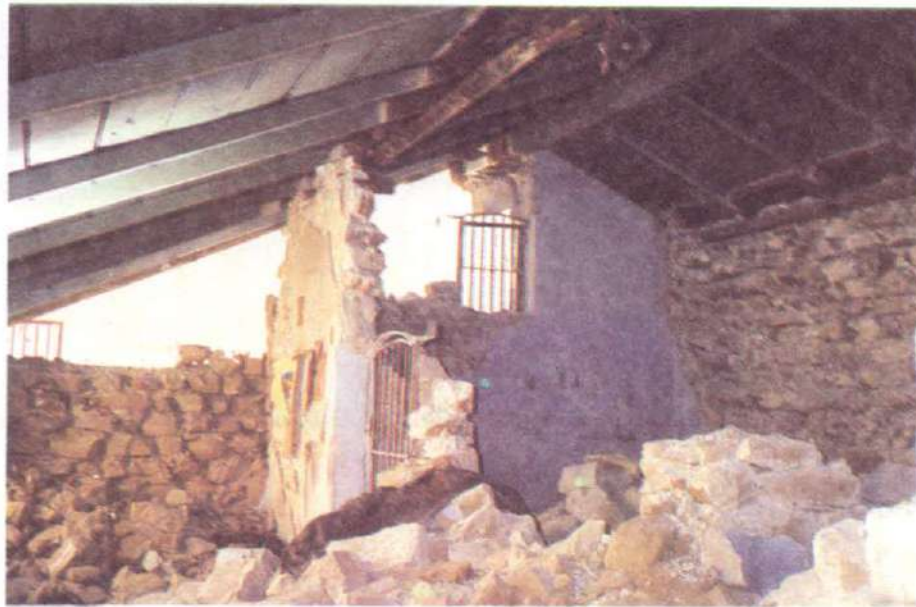
Fig. 18 Damaged jail in upper Chamoli

In Upper Chamoli, the Chamoli jail was totally damaged and six deaths were reported. The jail was constructed in 1902 using large size irregular stones with mud mortar having about 2 ft thick walls. Due to lack of 'through' stones the thick wall got separated and the heavy stones fell during severe ground shaking causing deaths and injuries to jail inmates (Fig. 18). Similar was the case of women prison, which is a part of the main jail. Intensity VIII is assigned to Chamoli.

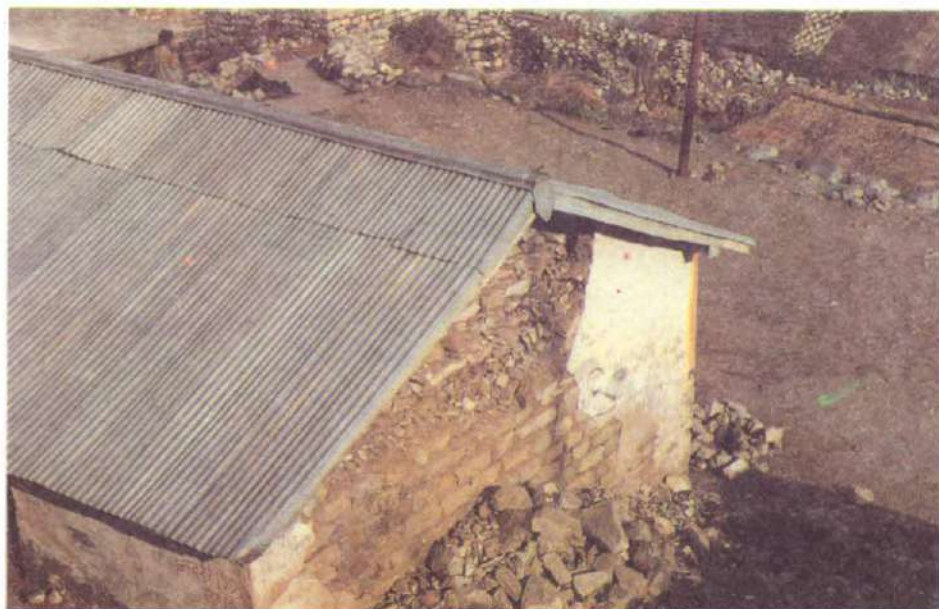
Fig. 19 Damaged house in Ghingrana

The village Ghingrana, located about 5km from Gopeshwar, experienced total damage of Grade 4 to 5 to most of the houses of Category A (Fig. 19). NE-SW motion was reported during the earthquake and the walls in NW-SE direction experienced more damage in comparison to NE-SW walls. People were unable to differentiate the vertical and horizontal motion. Intensity VIII is assigned to Ghingrana.

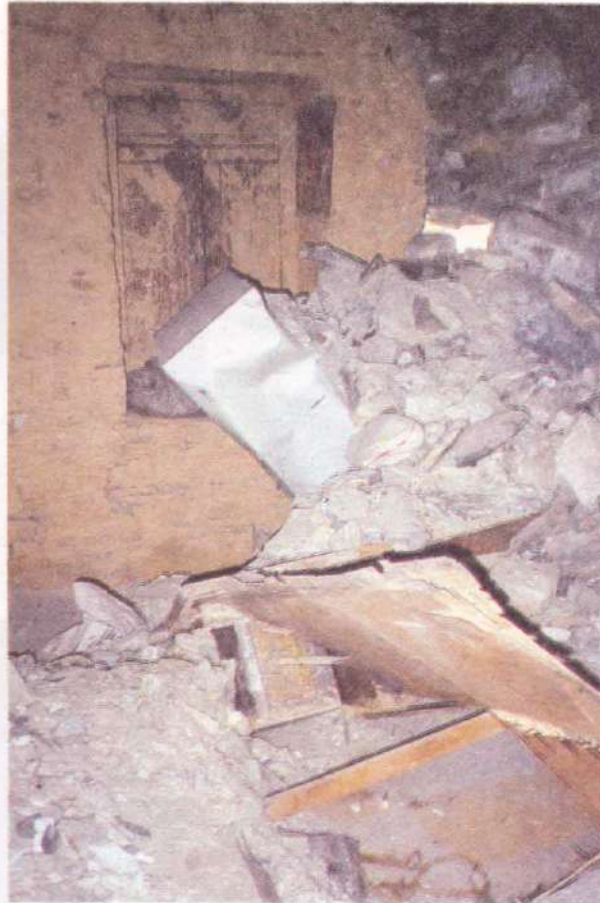
Fig. 20 Damaged house in Birhi

In the village Birhi, located at about 6km from Chamoli, more than 70% of the kutchha houses (Category A) experienced Grade 3 to 4 damage (Fig. 20). The owner of the Tapovan guesthouse reported the sudden change in the behavior of her pet dog before half an hour of the occurrence of the earthquake. The dog was very unrestful and running as if wanted to hide itself somewhere. The houses in the interior of the village, situated on the bank of river Birhi at about half km from the main road, were totally damaged. Intensity VIII- is assigned to this place.

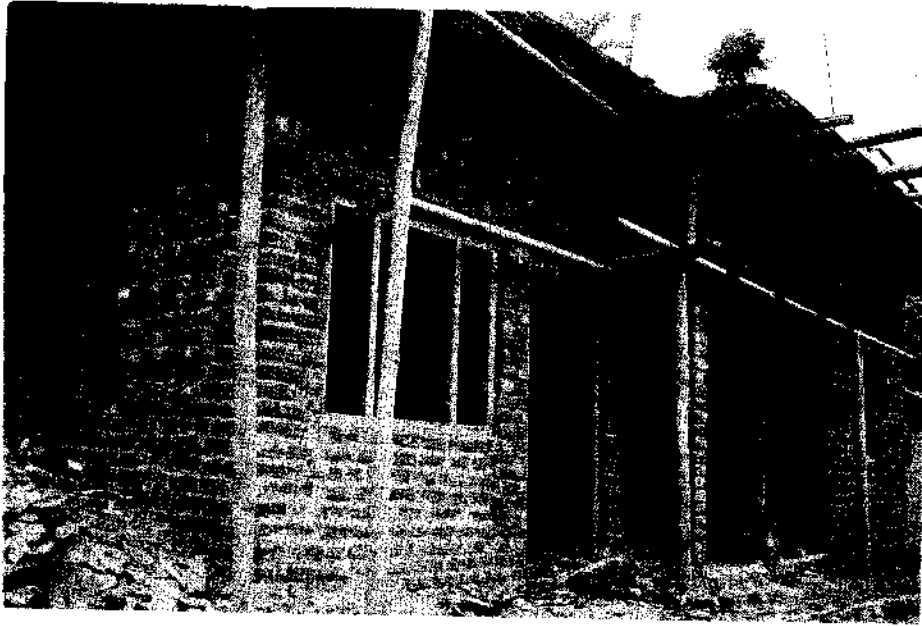
Fig. 3 Clay brick masonry house under construction. Note lintel band and gci sheets for placing the concrete slab.

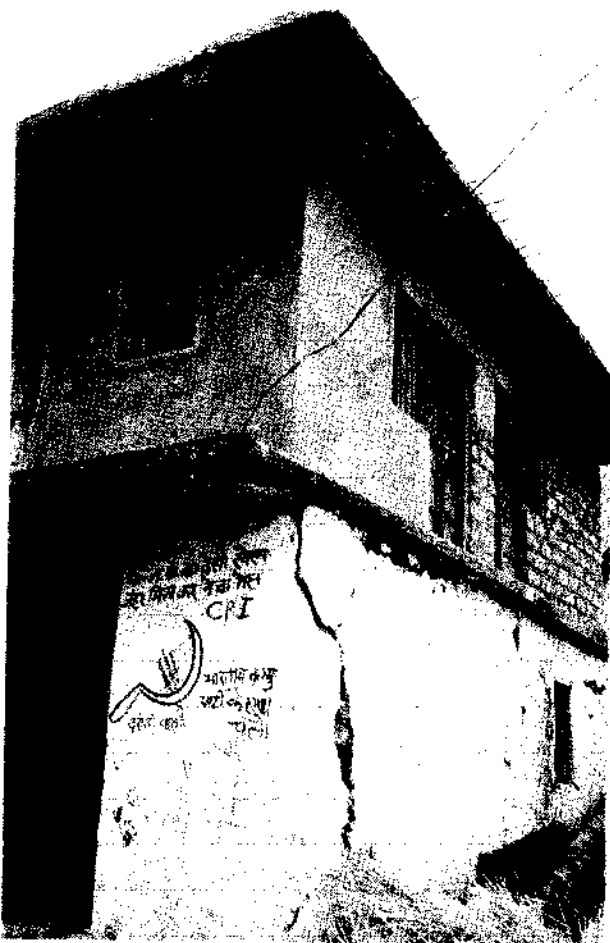
Fig. 4 Second storey addition in concrete blocks where the ground storey is in r/r stone masonry.

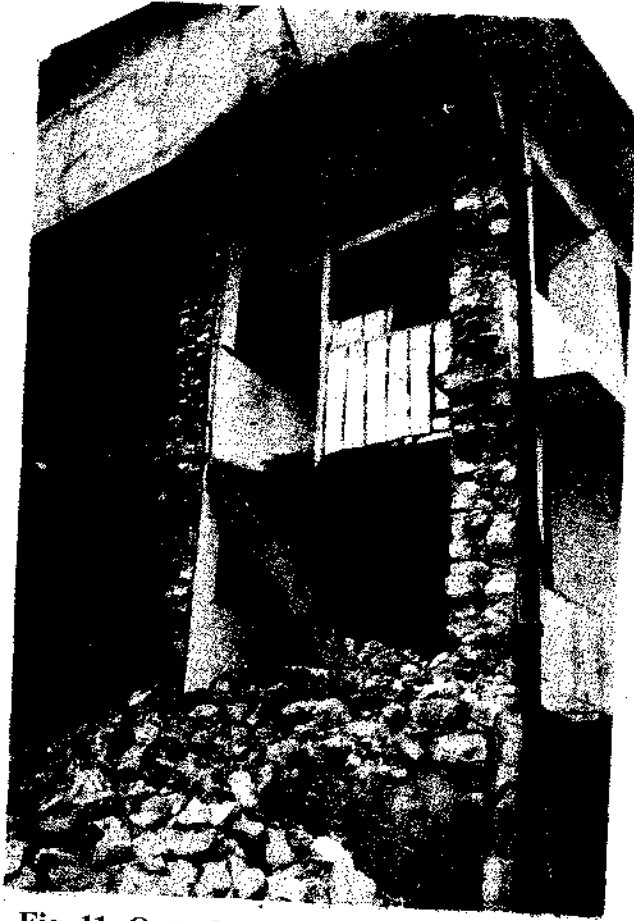
Fig. 11 Out-of-plane collapse of r/r stone masonry walls.

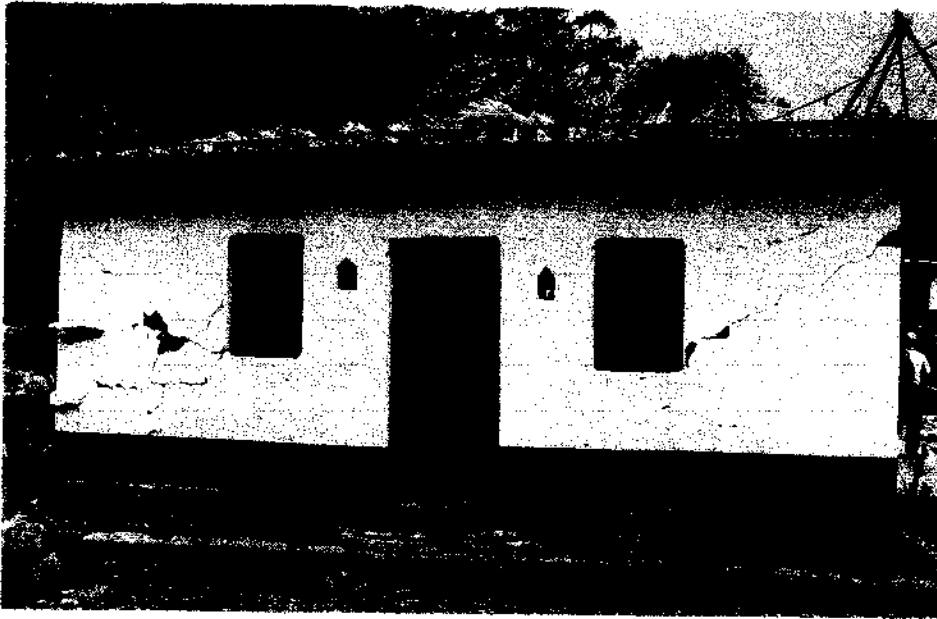
Fig. 13 Diagonal and x type shear cracks in newly built stone masonry house.

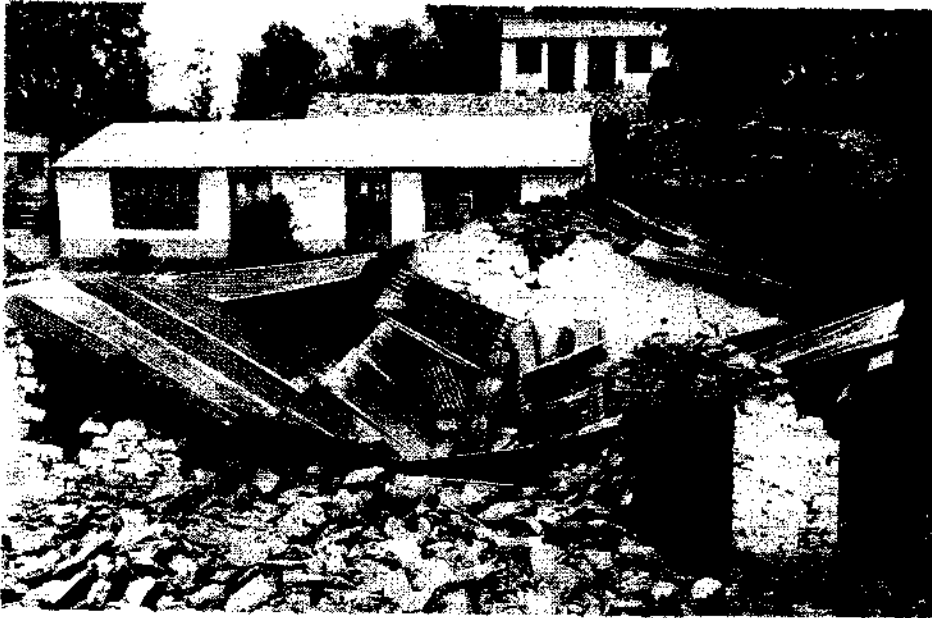
Fig. 14 Total collapse of roof due to out-of-plane failure of supporting wall and the roof supporting structure (school building, Bairagana).

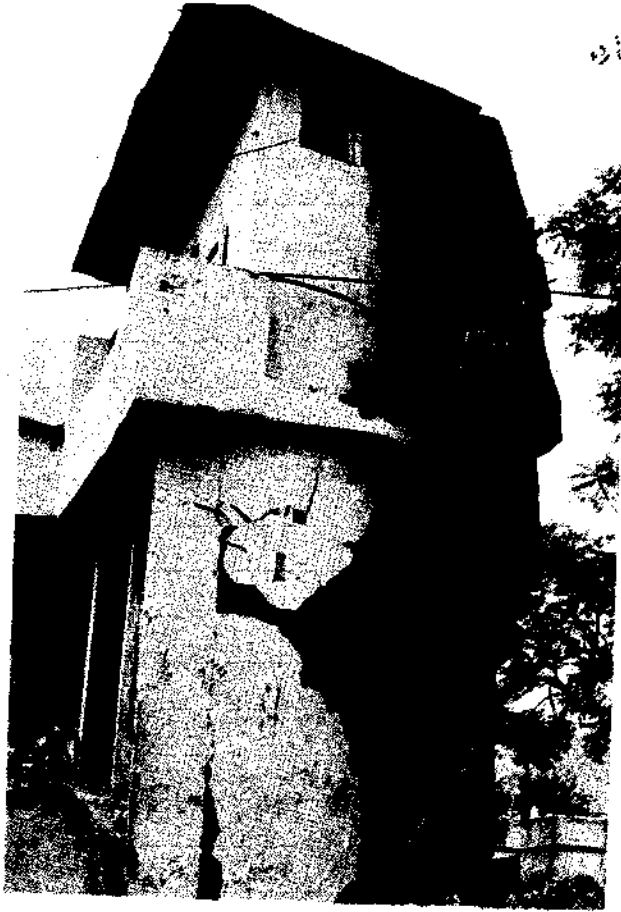
Fig. 15 Non-parallel vertical system for a corner building (Lower Chamoli).
