people who lost their lives during August 21, 1988 Earthquake

1. INTRODUCTION

5. DAMAGE SURVEY REPORT 12

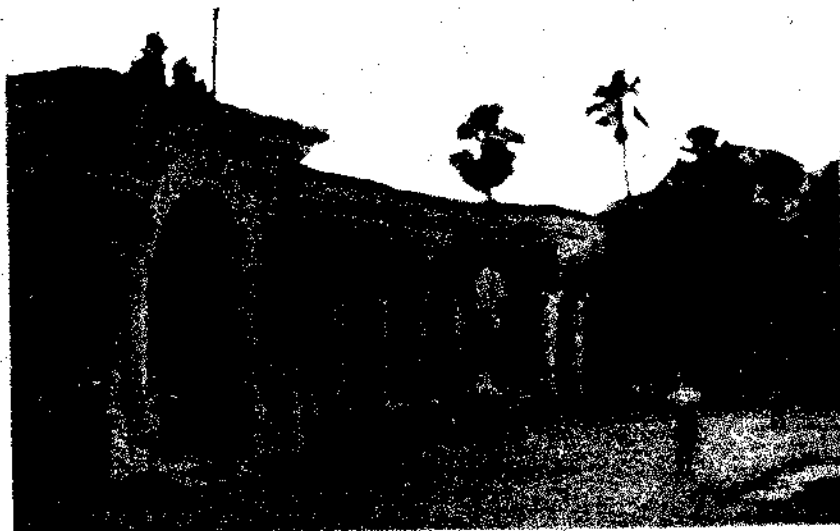
**Photo 10(a) Dilip dharamshala, Munghyer
(badly damaged in earthquake)**

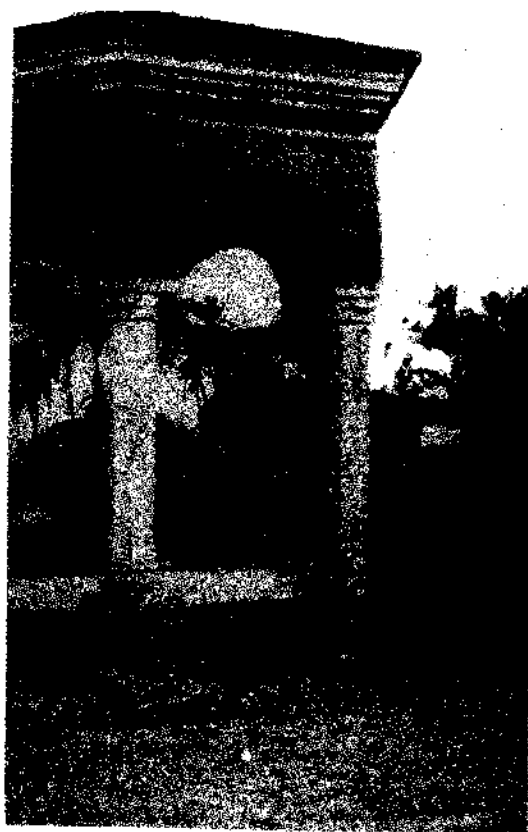
**Photo 10(b) Dilip dharamshala, Munghyer
(failure of arches, columns, roof)**

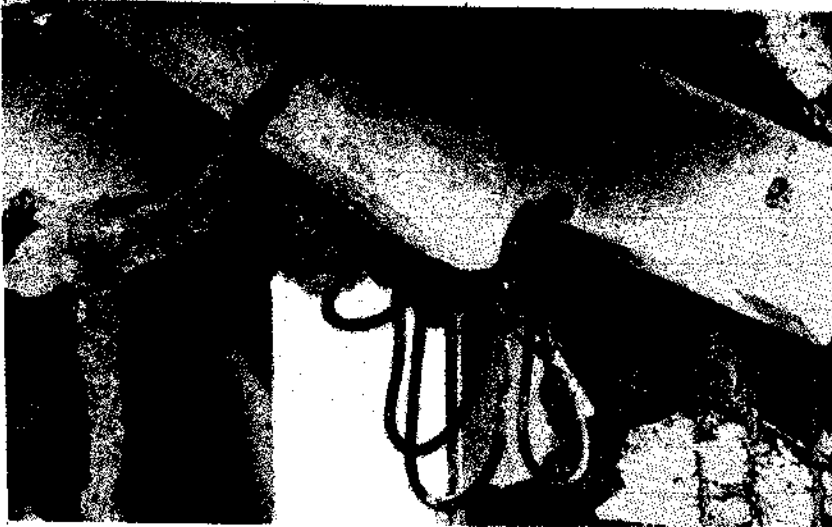
Photo 16(b) Cracks at top of columns, Munghyer

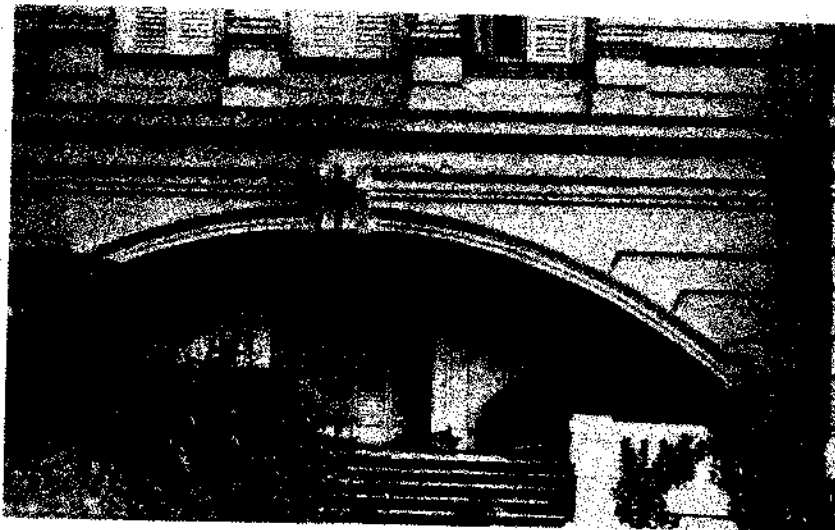
Photo 17(c) Telegraph office, Munghyer
(diagonal/horizontal cracks in inner walls)

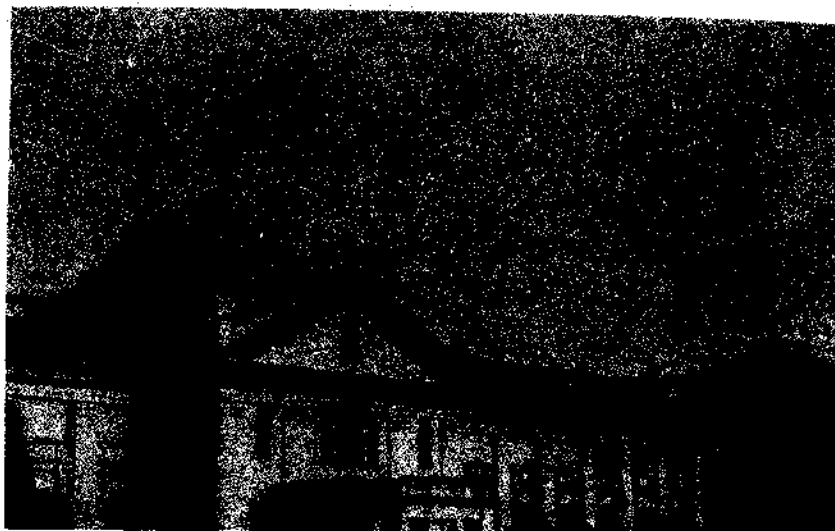
Photo 18(c) Raj bhawan, Patna cracking of arches, roof)

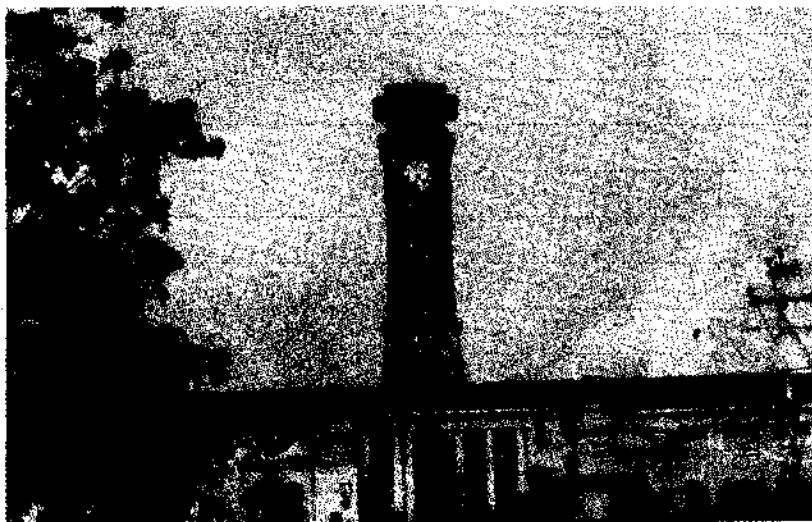
Photo 19(e) High court building, Patna
(separation of walls at corner)

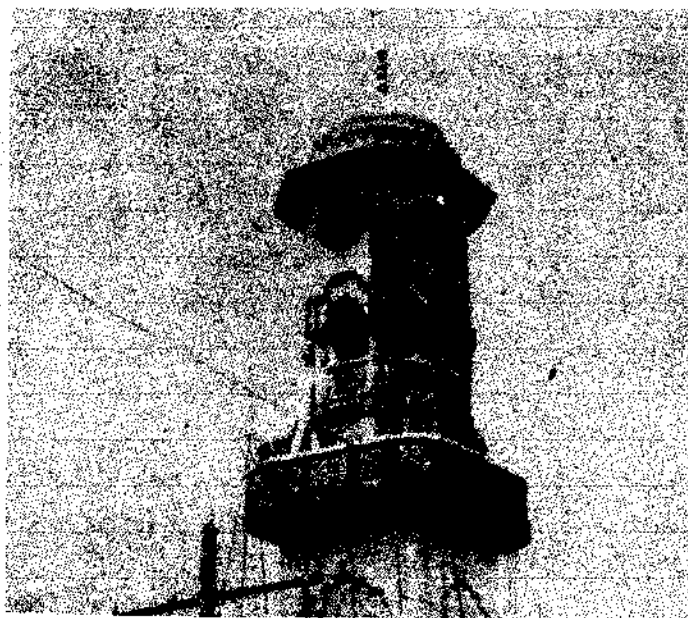
Photo 22(b) Shiva temple (cracks in dome)
