UTTARKASHI EARTHQUAKE

OCTOBER, 20, 1991

GEOLOGICAL SURVEY OF INDIA

SPECIAL PUBLICATION NO. 30

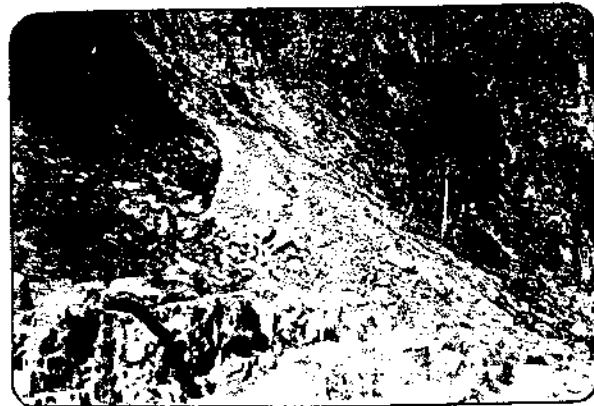
Photo 1 *Rock fall cum debris slide initiated in quartzites upslope of the road about a km before Maneri. Note uprooting of a telephone pole in the toe portion of the slide.*

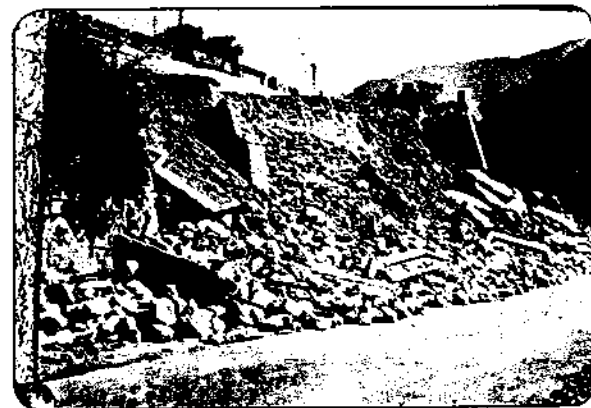
Photo 2 *Failure of buttressed breast wall of the approach road to Maneri colony. (Photo NGRI).*

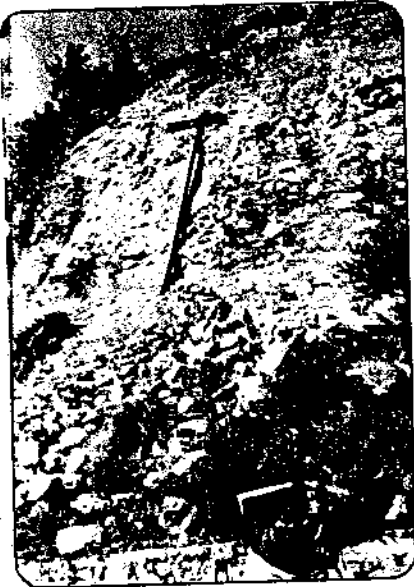
Photo 3A Failure of breast wall leading to collapse of telegraph pole near Gawana gad bridge.

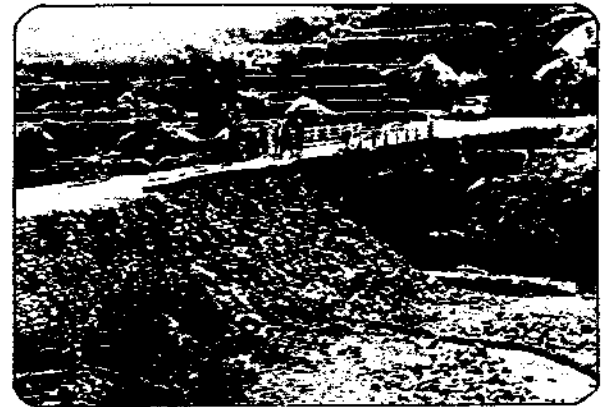
Photo 7 Damaged approaches of the bridge over river Indravati near Kishenpur. See undamaged RCC bridge of about 15 m. span.

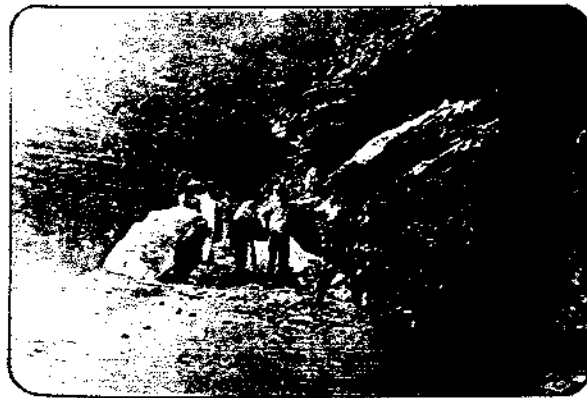
In this road sector no landslides or dislodgements are recorded between Bhaldiana and Lambgaon but from Lambgaon to Dhauntri a number of rock dislodgements have been noticed. Between Lambgaon and 5km. beyond the Jalkur nala bridge, 31 dislodgements of rock blocks varying in size from 1m³ to 10m³ (Photo 8) as well as 10 rock slides have been recorded which have been caused by this event. An old landslide on the left bank of a bridge near Thatl Remoli has got reactivated. All these dislodgements and slides are located in the Chamoli quartzites. Between Dhauntri and Suknidhar and the Dunda sector similar dislodgements have been recorded. Between Chakone and Suknidhar a

Photo 8 Rock dislodgement on Lambagoon-Rautalghar road section.

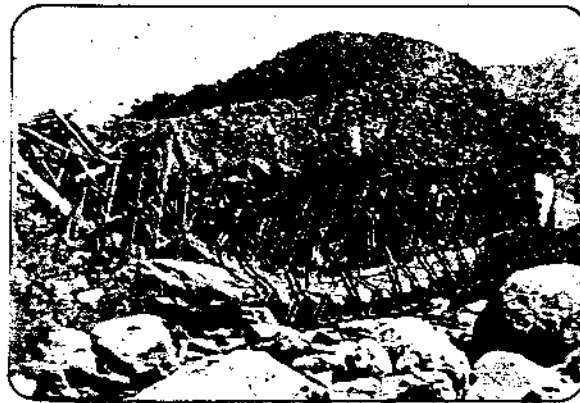
Photo 17 Collapsed Gawana gull lodge in Uttarkashi Maneri road sector.

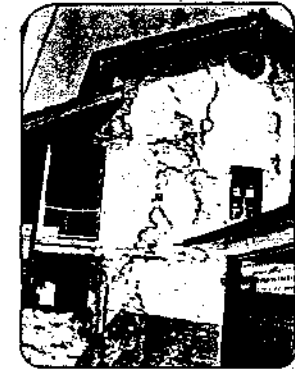
Photo 20 A A view of damages suffered by a conventional construction in Uttarkashi town. (Photo NGRI).

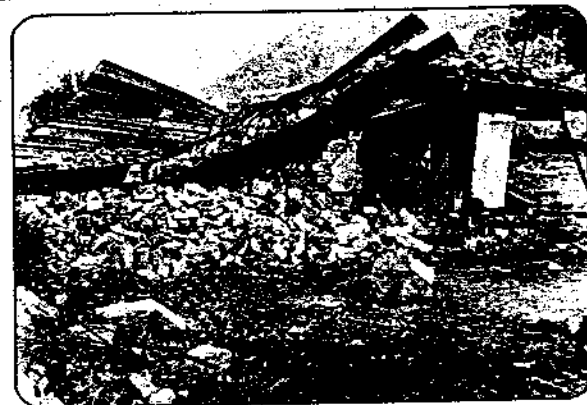
Photo 33 Complete collapse of a school building in Jakhol village.

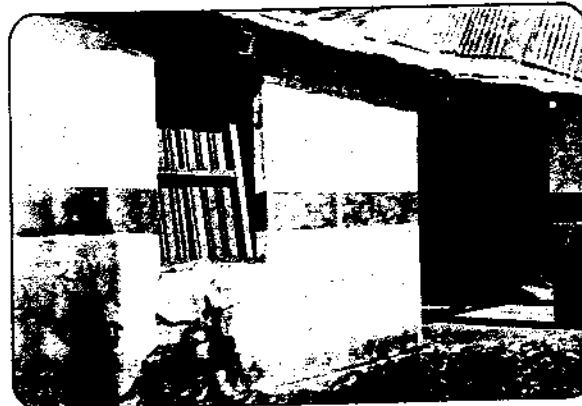
Photo 34 Tilted window of a school at Aghora and partial collapse of partition walls.

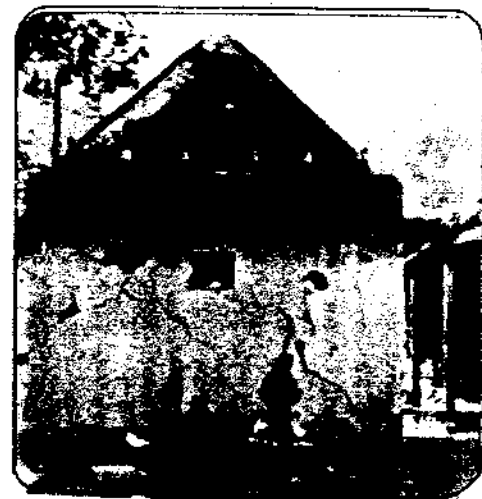
Photo 40 Open shear cracks in the temple in Nevala village. Spire thrown down in N70°E direction.

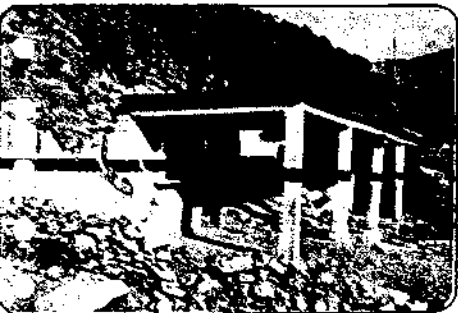
Photo 41 Severely damaged school building in Heena.

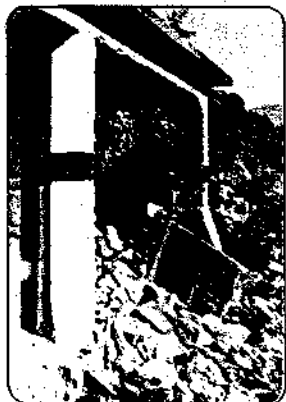
Photo 42 Complete collapse of a non-load-bearing masonry wall of Heena School.

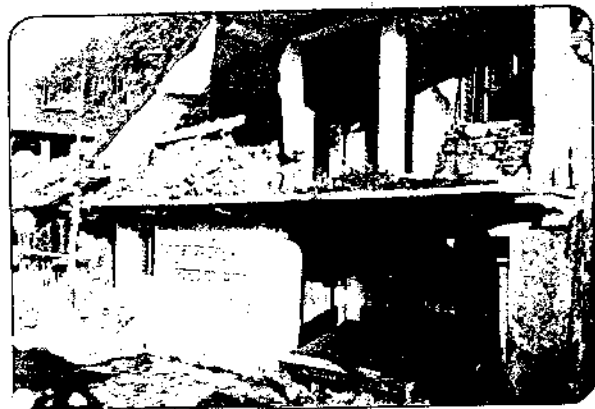
Photo 52 *Partial collapse of the first floor of a house in Dedsari. Note damages to RCC pillars and open shear cracks.*

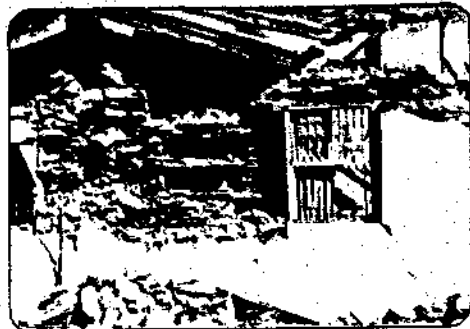
Photo 57 Partial collapse of mud masonry side walls of school building in Raithal village.

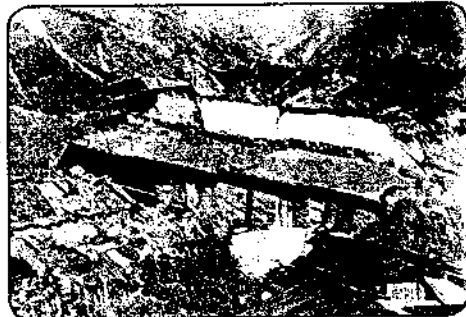
Photo 58 Extensive damage to conventional type-A houses. Collapse of walls and resultant breaking of concrete slab in one of the houses in Raithal village.

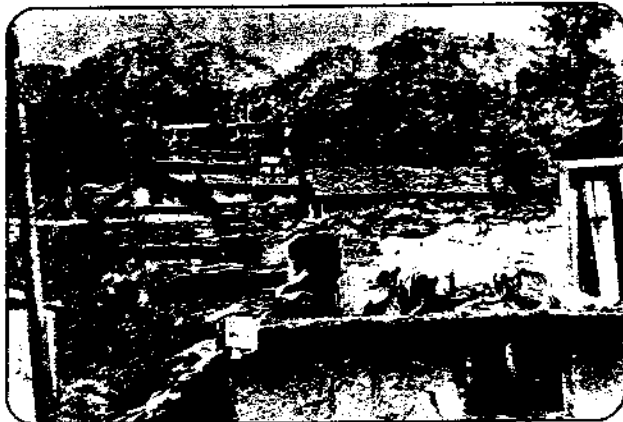
Photo 67 General view of Manupur village displaying damages.

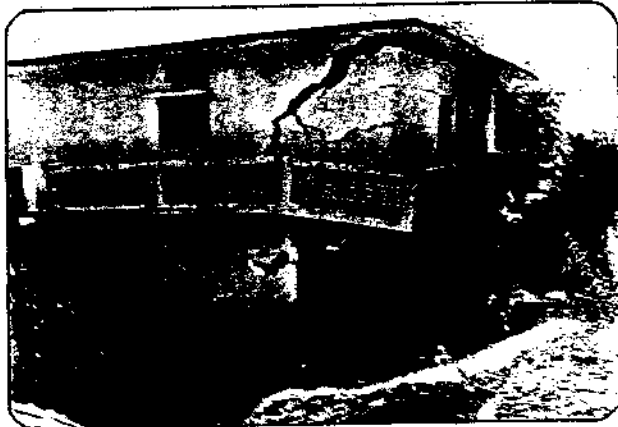
Photo 73 Tilting of the first floor frontage of a double storey house because of the collapse of the ground floor wall in village Gyansu.

Over 50% type-A houses are essentially of poor quality, being made of undressed stone masonry set in mud mortar. One of such houses had suffered damage of Grade 4 (Photo 72). It is clearly seen from the photograph (Photo 73) of the house that the back and side walls of the ground floor have completely collapsed. The back and side walls of the back portion of first floor has almost dislodged from the main building and hanging in air, leaving a zig-zag crack with a gap of approx. 40cm. The shear crack starts from the roof level of the wall and extends down to the floor of the room dissecting the balcony. Also approx. 5cm wide open cracks running parallel to the junction of back wall with the roof slab have been noticed. The RCC roof has remained intact.

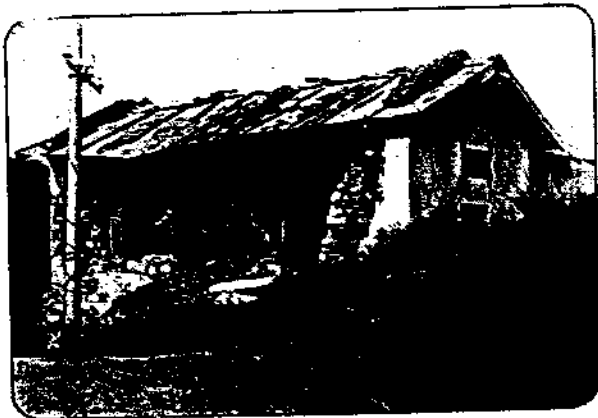
Photo 86 *Collapsed veterinary hospital in Jakholi village.*

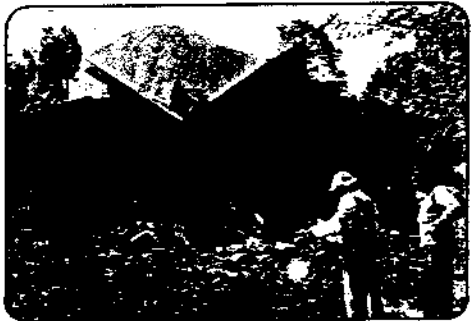
Photo 92 *Caving in of the roof of a conventional construction because of partial collapse of supporting walls, Gangani village.*

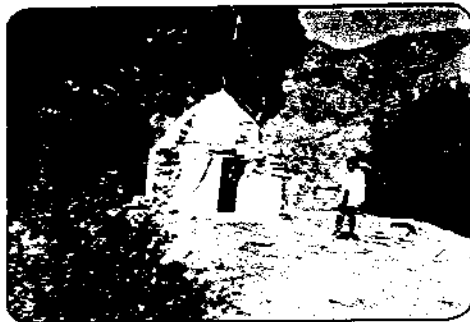
Photo 92 A *Damaged lowrise roadside temple, a few km before Barkot along Kalsi-Barkot road.*

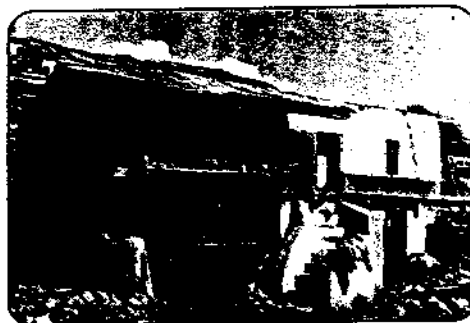
Photo 94 *Bulging and cracking of walls of a house in Purota village.*

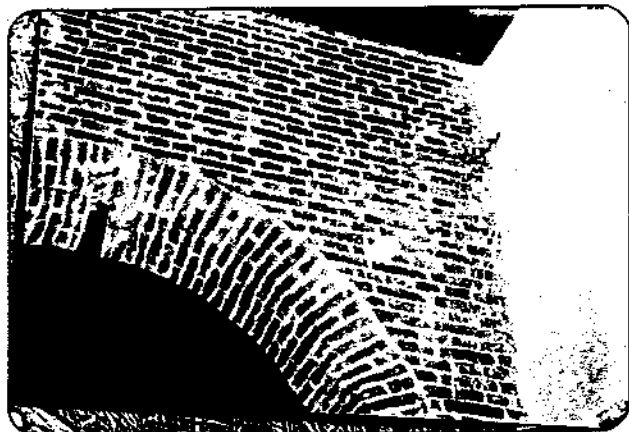
Photo 101 *Partial collapse of gable portion of a type-B construction (dispensary building) at Chitkul.*

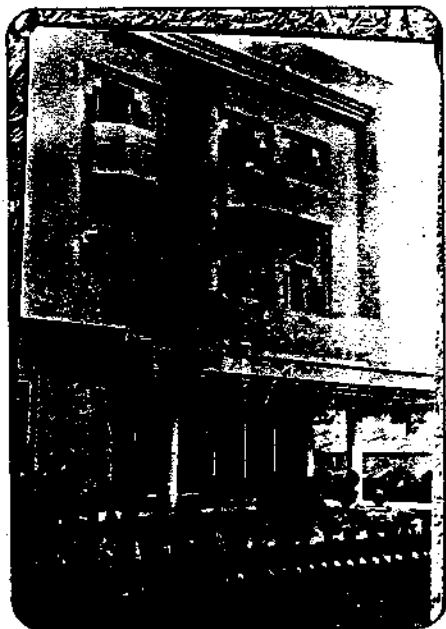
Photo 99 *Partial collapse of an old house in Kunihar village.*

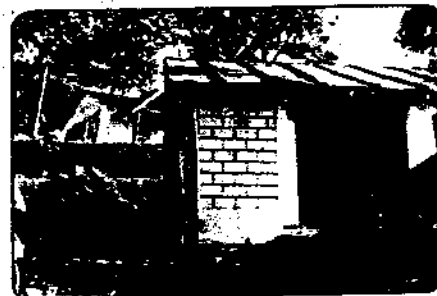
Photo 107 Northward bulging in short wall of Okhimath Public Health Centre.

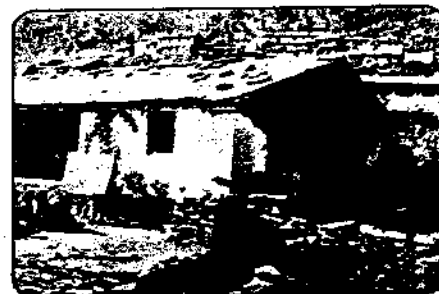
The influence of the 20th October earthquake was quite severe in the area. Almost 80% of the poorly constructed type-A structures, that is houses of thick mud masonry walls with slate roofing developed open cracks and nearly 20% suffered partial collapses, particularly of the gable portion (Photos 108 and 109).

Photo 109 Collapse of short wall of the School building, Trijugi Narayan.

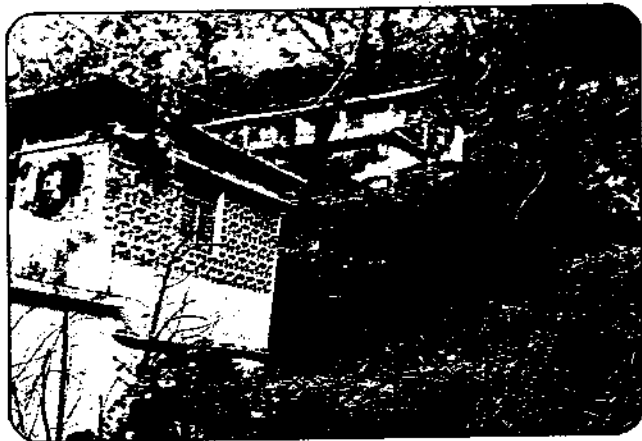
In case of buildings and houses, the damage includes cracks in buildings. These cracks are open in some cases. The crack openings are more pronounced on southwestern walls of NE-SW aligned structures like Rest House of Garhwal Mandal Vikas Nigam. The cracks on SW wall of the NE-SW aligned buildings are open upto 5.0cm near the top portion. The openings gradually decrease towards bottom. Few SW and NE walls of Kutcha houses have collapsed partially (Photo 110 and 111).

Photo 110 *Plaster fall of the house in foreground and partial short wall collapse of the house in the background at Gaurikund.*
