UTTARKASHI EARTHQUAKE

OCTOBER, 20, 1991

GEOLOGICAL SURVEY OF INDIA

SPECIAL PUBLICATION NO. 30

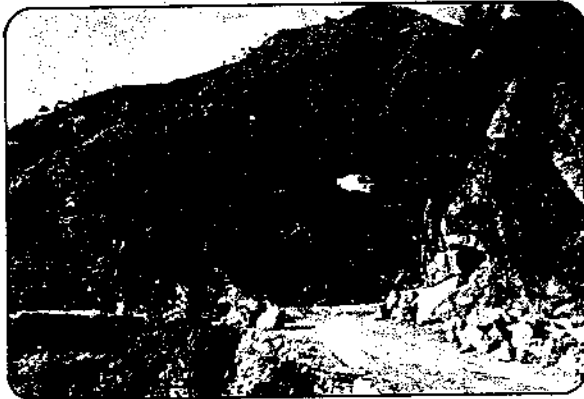
The road sector between Tilwara in Mandakani valley and Chirbatia water divide of Bhilangana catchment is marked by isolated rock dislodgements. These dislodgements, prominent between Tilwara and Mayali village, are confined to the highly jointed basic rock constituents within the gneissic and granitic rock complex. The dislodgement incidences increase considerably from Mayali towards Gorthi village and infact, in a distance of about 2km., more than 15 dislodgements have been seen in a basic rock exposure near Mayali. Incidentally the boundary of isoseismal VII passes very close to this location. Dislodgements have also been seen in the gneisses exposed in the vicinity of Gorthi village, located on a spur (Photo 9).

Photo 9 *Dislodgement of rock blocks near Gorih village. Partial collapse of the short wall of a village house in the background.*

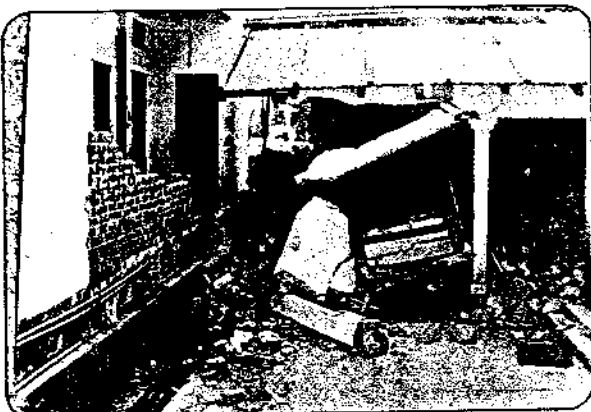
Photo 22 Collapse of pillar and beam of the verandah of a house in Police Lines, Uttarkashi.

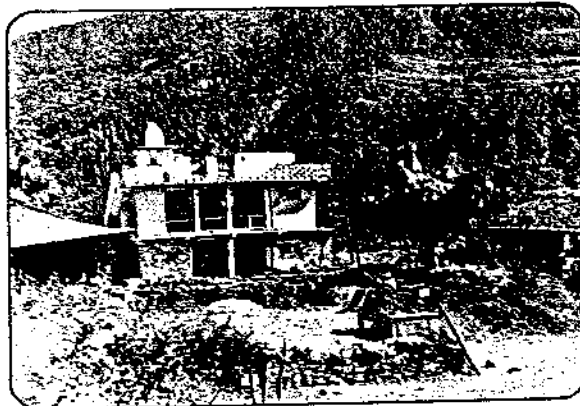
Photo 32 Shear cracks in the ground and first floors of a house in Ghorsali village.

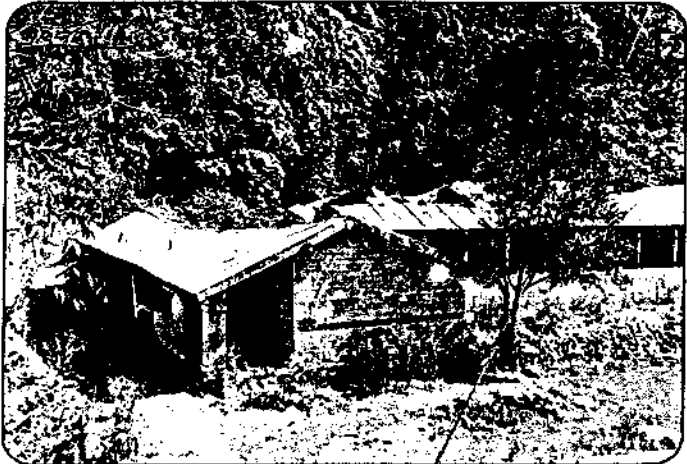
Photo 36 Collapse of the northern wall of a school building at Kalyani.

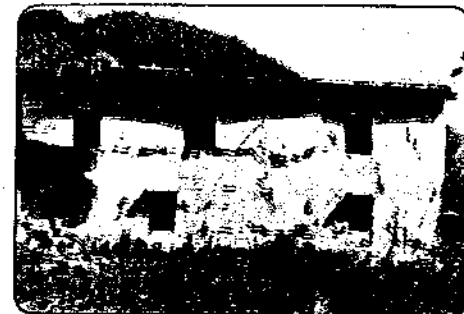
Photo 38 Collapse and cracks in the long walls of a house in Ganeshpur village.

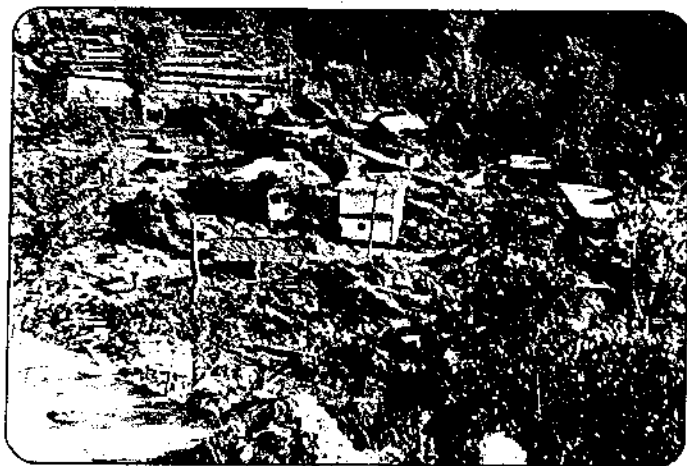
Photo 45 Devastated Jamak village.

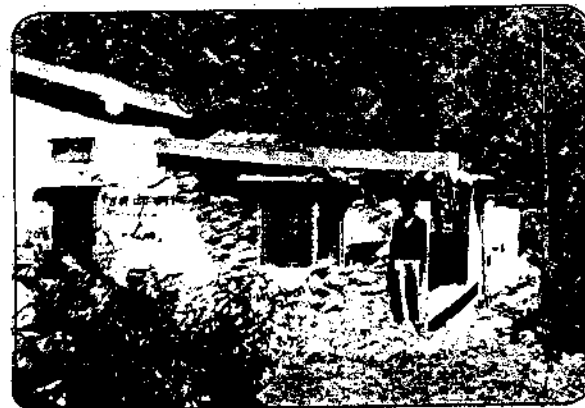
Photo 55 *Collapsed school building in Sanglai village.*

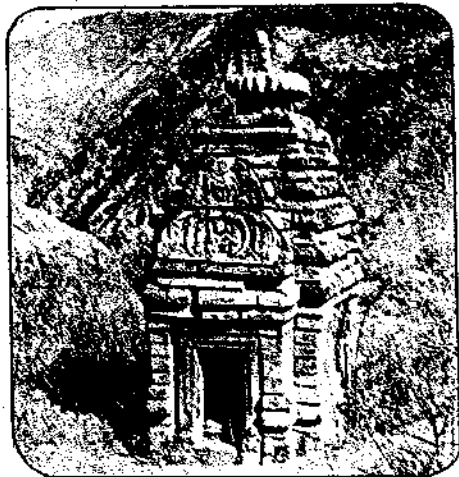
Photo 57 A Old temple near Raithal village, displaying shifting of top cupola (kalash).

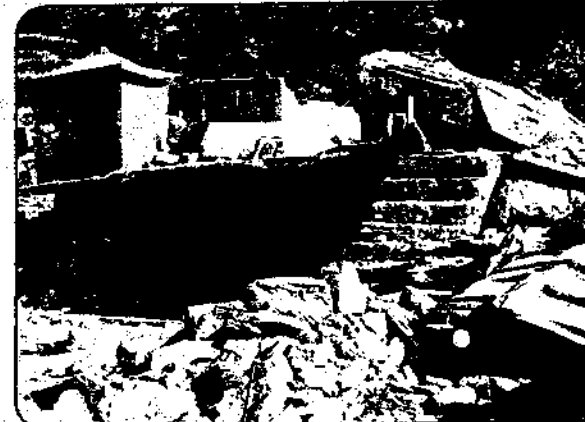
Photo 70 Collapse of first floor of a house in Byala Tipri village with deep open cracks in the ground and first floor. (New construction).

The old houses constituting almost 70% of the village dwellings are constructed of masonry walls with mud mortar and slate roofing. Such structures have suffered grade 3 and grade 4 damages in form of partial collapses, open cracks and bulging of walls (Photo 70). Some of the new constructions have replaced masonry with pre-cast concrete bricks and the slate roof with RCC slab. In such houses the failure of the side walls has led to partial collapse of the roof slabs which have acquired a tent or a hut like shape when viewed from a distance (Photo 71). The damages in first floor have been found to be more severe than the ground floor.

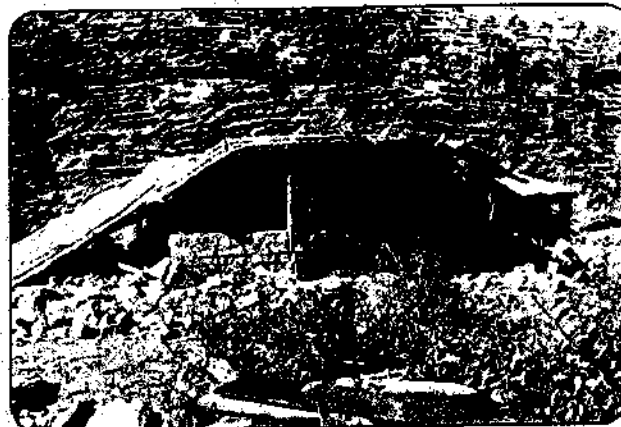
Photo 71 Partially collapsed end have resulted in a hut-like structure of the RCC roof slab in Byala Tipri village.

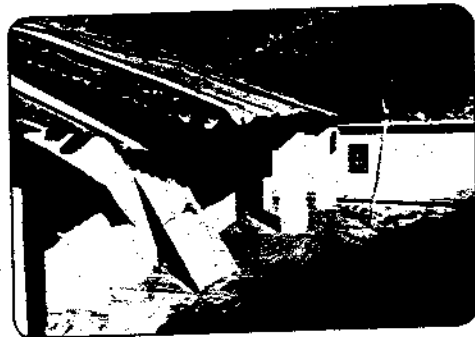
Photo 88 *Damage to cluster of houses in Gangani village.*

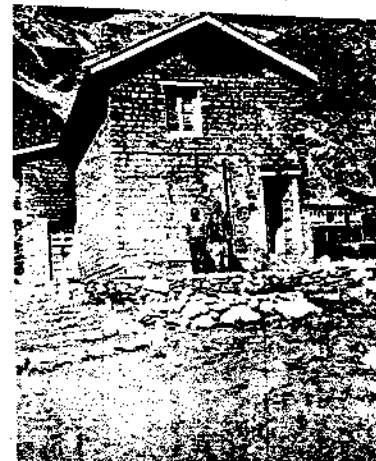
Photo 100 Vertical crack with 5-6 cm. opening in a kutcha house in Kunihar.
